Slope Stabilization of a Section of the Welland Canal

Dennis E. Becker
Ph.D, P.Eng., FEIC, FCAE

Principal
Golder Associates

April 2012

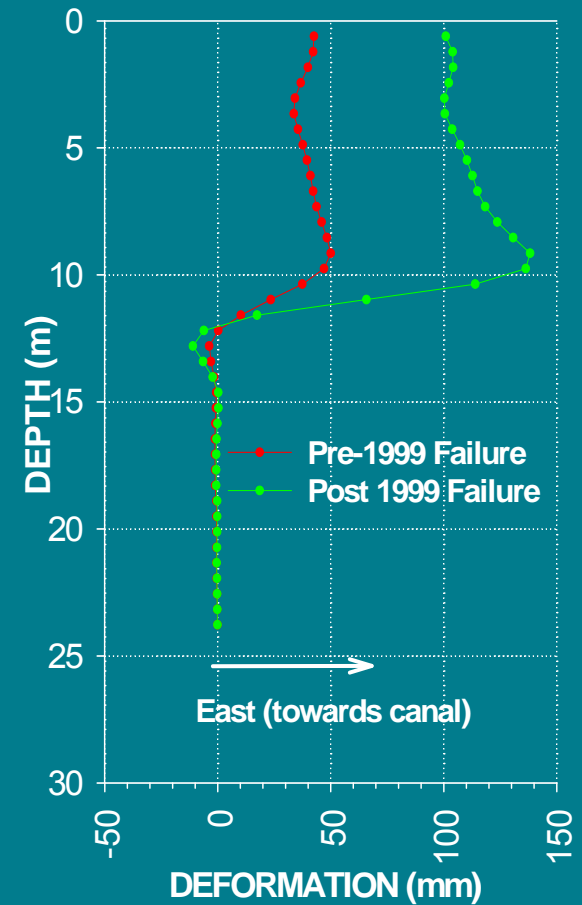
Profile of Slope Indicator 52
Pre and Post 1999 Slope Failure

- Monitored ground and pier structure movements since 1986
- Slope moved laterally by as much as 230 mm as a result of cycles in operational canal water levels
- Pier movement essentially elastic
 - Permanent plastic deformation of 3 mm to 6 mm in 15 years
- Pier movement due to ground movement adjacent to pier
