EXPERIMENTAL INVESTIGATION OF THE COMPOSITE ACTION BETWEEN HOLLOWCORE SLABS WITH MACHINE CAST FINISH AND CONCRETE TOPPING

Aiham Adawi¹, Maged A. Youssef^{*,1}, Mohamed E. Meshaly²

¹ Department of Civil and Environmental Engineering, Western University, London, Ontario, Canada, N6A 5B9

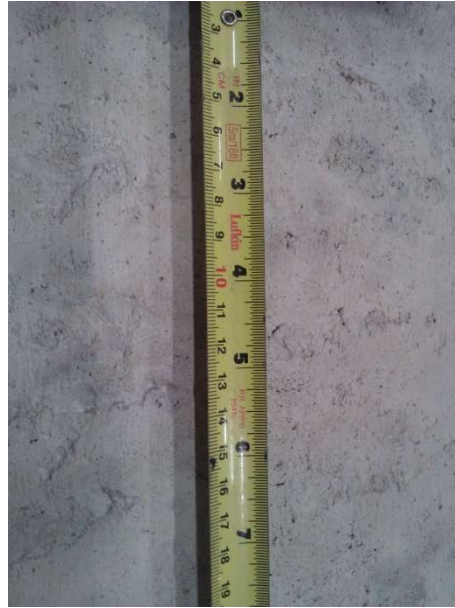
Fig. 1: Typical machine cast finish.

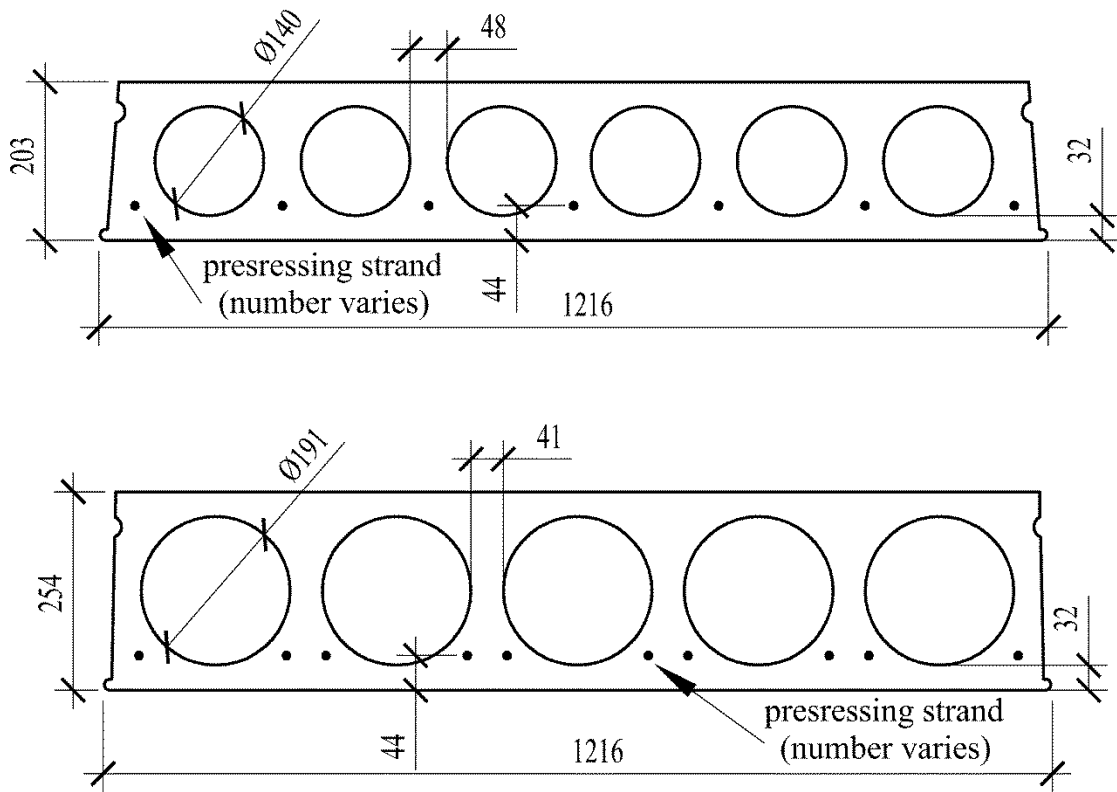
Fig. 2: Cross-sections of the tested hollowcore slabs (all dimensions are in mm).

The tested hollowcore slabs were received in four shipments from two manufacturers (A and B) located in Ontario, Canada. Table 1 summarizes information about the tested slabs and the conducted tests. Figs. 1 and 2 show their machine cast finish and their cross-sections. The minimum concrete compressive strength was 41 MPa as per manufacturer's specifications. The concrete compressive strength for the full-scale test specimens was evaluated using ASTM C349¹² using three 50 mm cubes sampled from the edges of each slab after completing the full-scale tests. The equivalent cylinder concrete compressive strengths are given in Table 2. Number of prestressing strands for each slab is also given in the table.

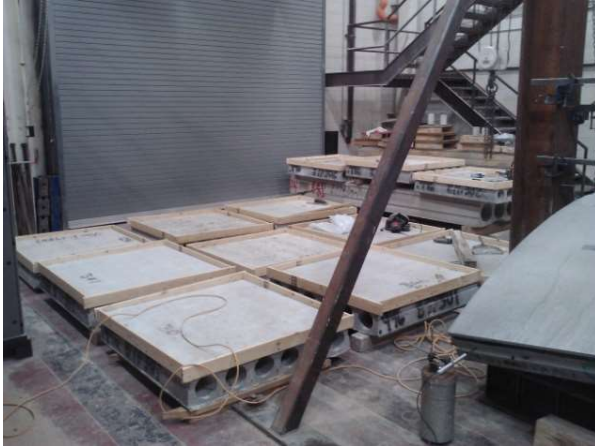
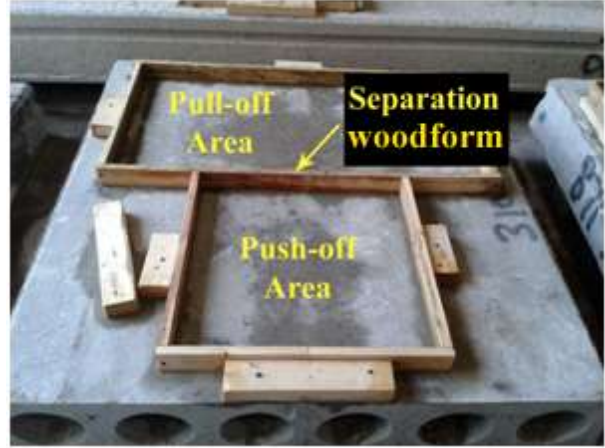
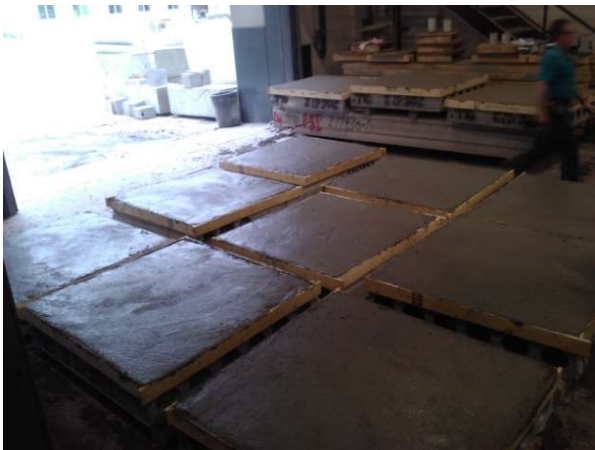
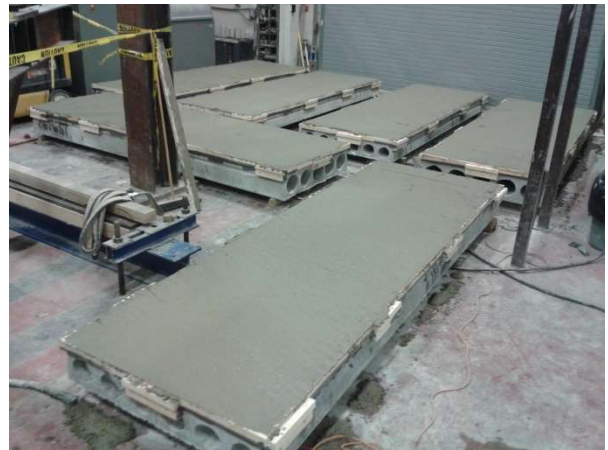
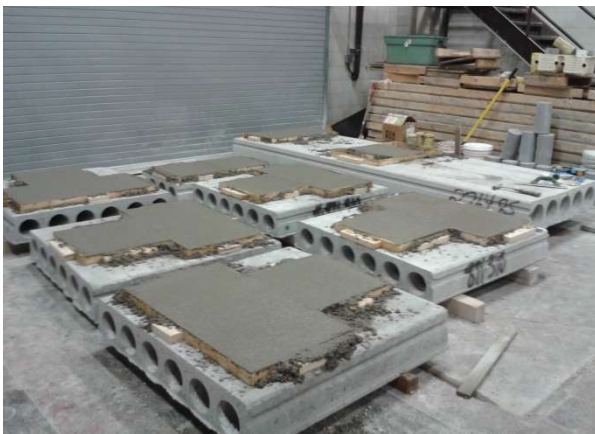
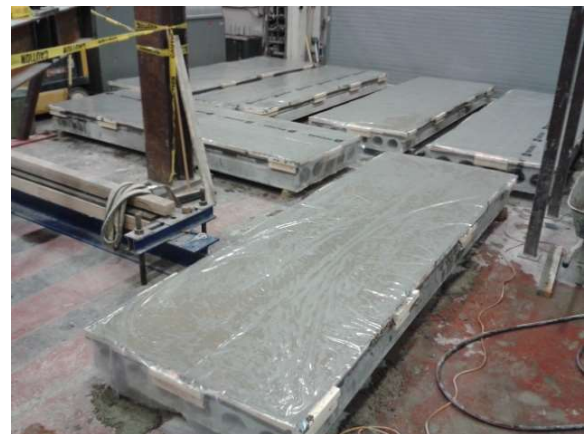
Fig. 3: Formwork and casting of the concrete topping.

(a) Before casting the topping.

(b) Before casting (4th shipment).

(c) After casting the topping (1st shipment).

(d) After casting the topping (2nd shipment).

(e) After casting the topping (4th shipment).

(f) Curing of the concrete topping.

an average slump of 120 mm. No additives were added to the mix and the specified strength was 25 MPa. Before casting the topping, the surface of the hollowcore slabs was submerged with water and then dried to obtain a Saturated Surface Dry (SSD) condition, which prevents the surface from absorbing water from the concrete topping. The area of the concrete topping varied as shown in Table 3. For the 4th shipment, two concrete areas were cast on each slab to conduct both pull-off and push-off tests. The two areas were separated by utilizing wood forms. Table 3 also presents the average compressive strength of the concrete topping as was determined using ASTM C39¹³. Wet curing was applied for three days according to clause 7.4.2 of CSA A23.1¹⁴. The slabs were also covered with moisture retaining plastic sheets for at least seven days after casting. Temperature of the laboratory was kept constant at 23° C. Formwork and casting of the concrete topping are illustrated in Fig. 3.

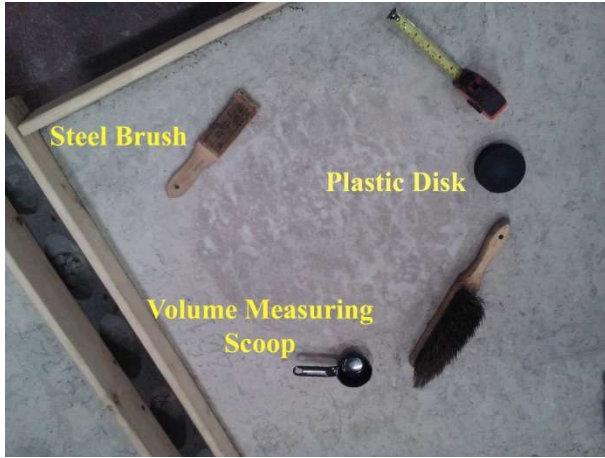
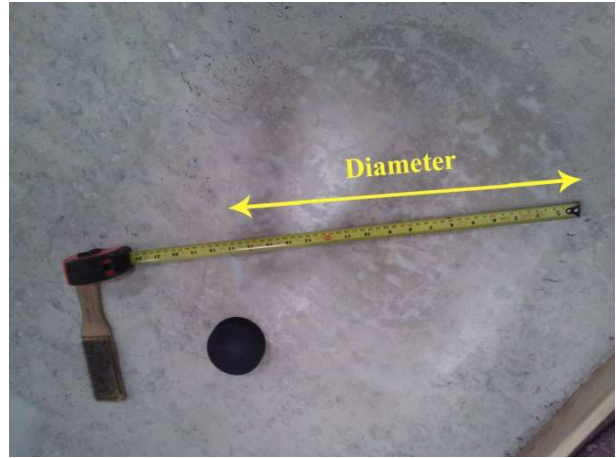
Fig. 4: Surface Roughness Test.

(a) Tools.

(b) Typical circle.

slabs with machine cast surface was evaluated using ASTM E965¹⁷. This procedure is generally used for pavements and is suitable for surfaces with voids smaller than 25.4 mm, which is the case for the considered surface. Glass beads that pass through sieve No. 60 and are retained on sieve No. 80 are spread over the slab surface in a circular motion using a hard plastic disk. When the beads are flush with the surface, three measurements of the diameter of the resulting circle are taken (Fig. 4). Mean Texture Depth (MTD) is then calculated by dividing the volume of the used beads by the average area of the circle. Results of surface roughness are shown in Table 4. It is clear that roughness of the machine cast finish is significantly less than the intentional roughness specified by North American design standards. The results also show the high variability of roughness from manufacturer to another and within the same manufacturer.

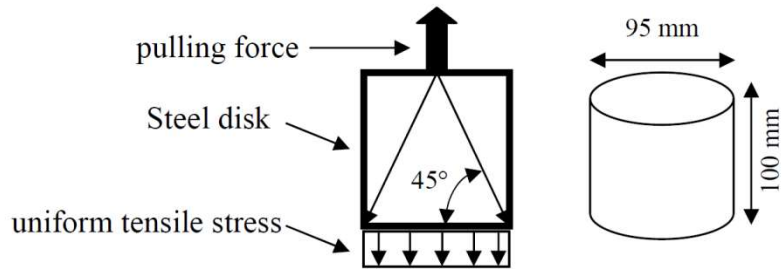
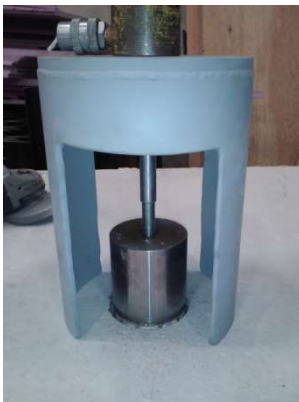
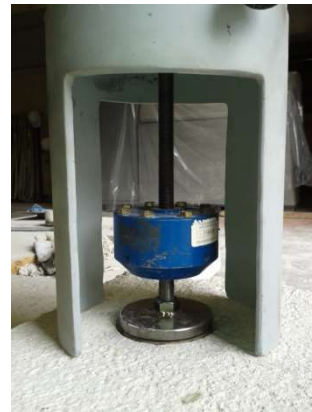
Fig. 5: Steel disks for the pull-off tests.

(a) Expected uniform stress distribution under disk No.1.

(b) Disk No. 1 (thickness = 100 mm).

(c) Disk No. 2 (thickness = 10 mm).

Pull-off tests were performed according to procedure A of the standard test method 6B of CSA A23.2¹⁵. In this procedure, the tensile strength of the interface between two bonded concrete surfaces is evaluated using a mechanical pullout apparatus that consists of three main components: 1) a pull-off steel disk, which is attached to the concrete topping; 2) a rigid frame to support the hydraulic jack applying the pull-off force and 3) a load cell to record the failure load. This apparatus was manufactured at Western University. The diameter of the used disks was 95 mm, which is slightly smaller than the inner diameter of the bit used for core drilling. Two disk thicknesses were utilized in this project: 1) 100 mm to ensure a uniform distribution of the tensile force over the interface area as illustrated in Fig. 5(a) and 2) 10 mm to match the common industry practice. The 100 mm and 10 mm disks were used for the (1st and 2nd) and the (3rd and 4th) shipments, respectively. The disks are shown in Fig. 5. A steel pipe with thickness of 10 mm

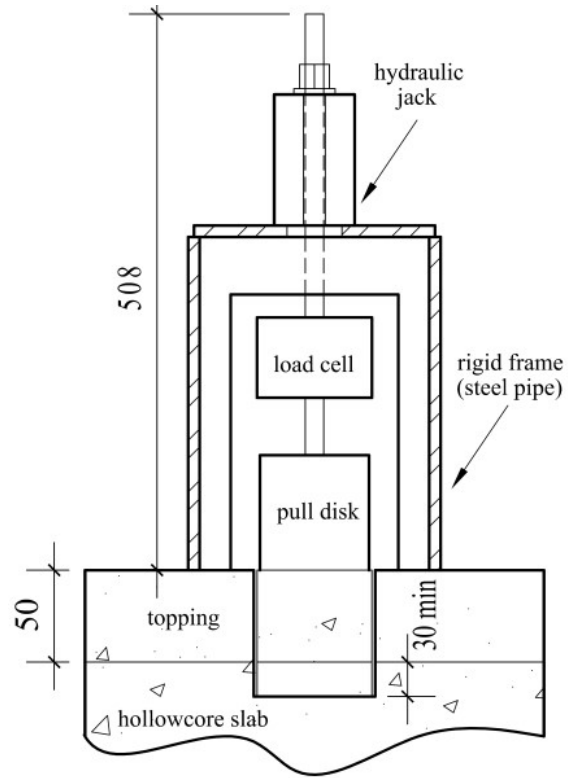
Fig. 6: Pull-off apparatus (dimensions in mm).

was used to provide the needed rigid frame. It encompassed the load cell and supported the hydraulic jack. Fig. 6 shows the pull-off apparatus and the general test setup.

Pull-off tests were initiated by drilling a core through concrete topping that penetrates a minimum of 30 mm into the hollowcore slab surface as illustrated in Fig. 6. The diameter of the core was 100 mm, matching the current industry practice. Fig. 7(a) shows the core drilling. The steel pull-off disks were bonded to the cores using epoxy compound after roughening the core top surface and the disk bottom surface as shown in Fig. 7(c). The disks were installed on the core using a conventional 5 minute epoxy compound. Fig. 8 shows locations of the cores for the tested slabs. Fig. 9 shows the process of leveling the pull-off disk and attaching the apparatus. Tests were conducted after 24 hours of the epoxy application. The load cell was first attached to the pull-off disk using a threaded rod. The rate of loading was approximately 80 N/s, which is within the (50 to 100 N/s) range specified in clause 5.1.4 of CSA A23.2-6B¹⁵. It was controlled by monitoring the digital load meter while increasing the tensile load using a manual hydraulic pump.

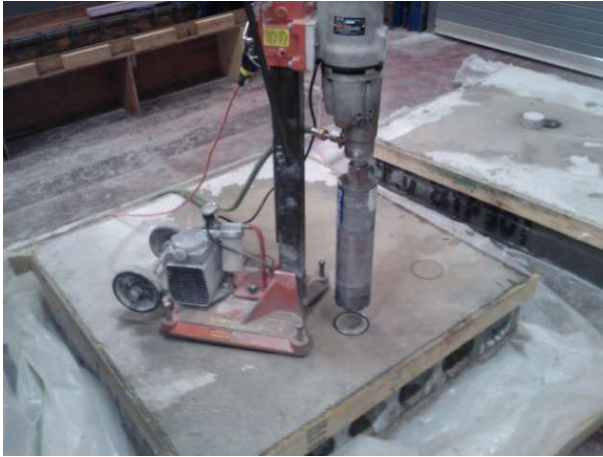
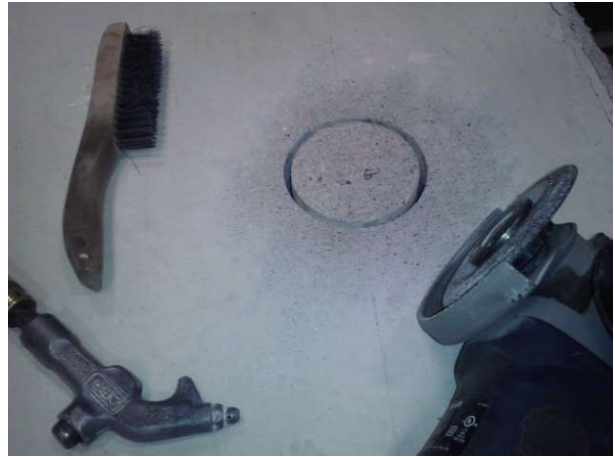
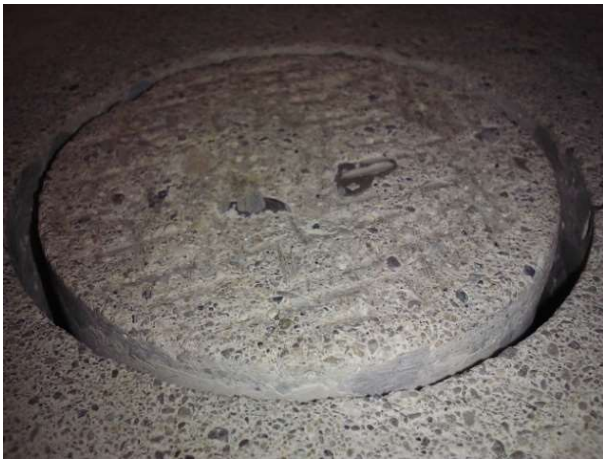
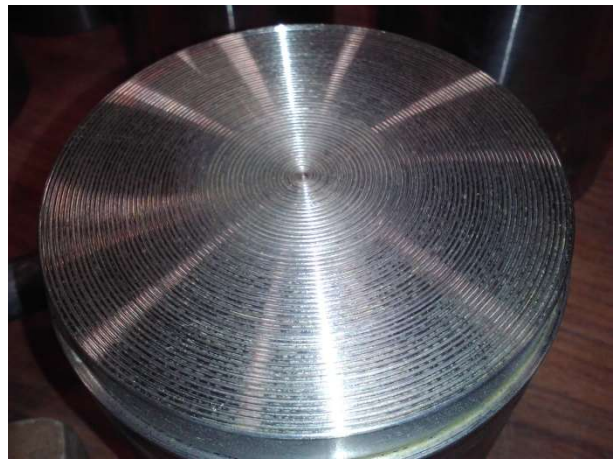
Fig. 7: Core drilling and roughening process.

(a) Core drilling.

(b) Core cleaning.

(c) Roughening of core surface.

(d) Roughening of disk bottom surface.

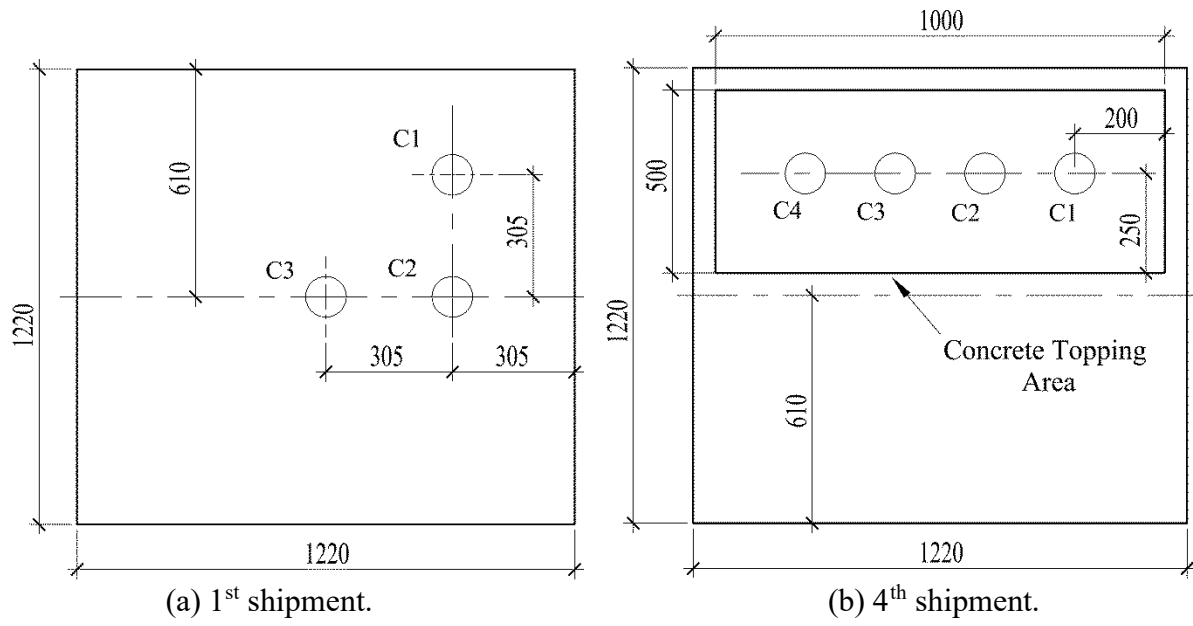
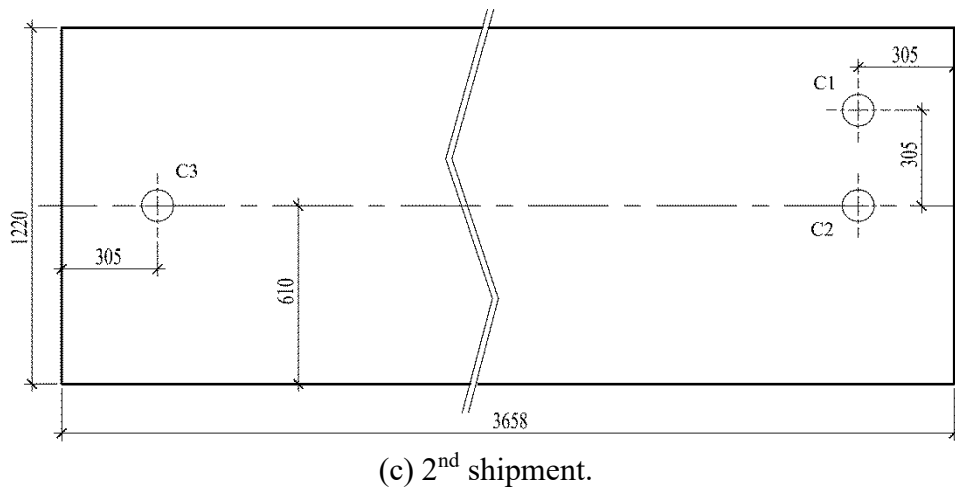
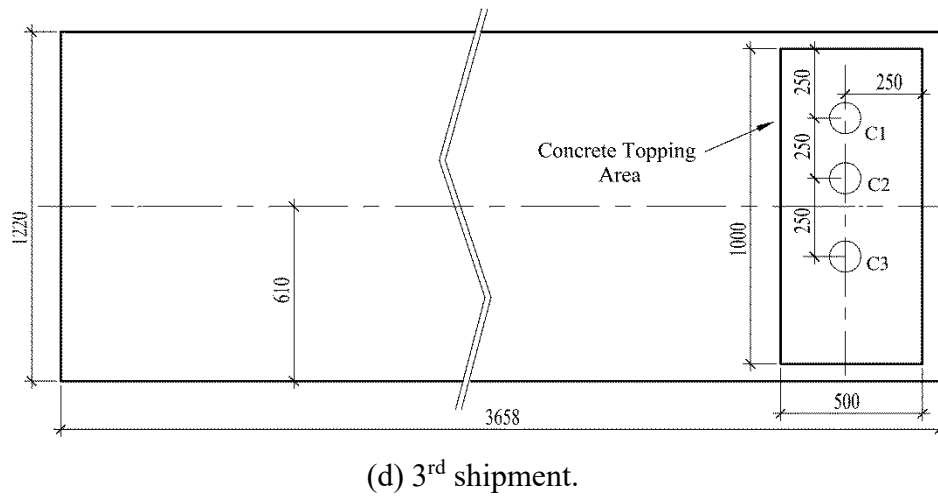
Fig. 8: Core Locations (dimensions in mm).

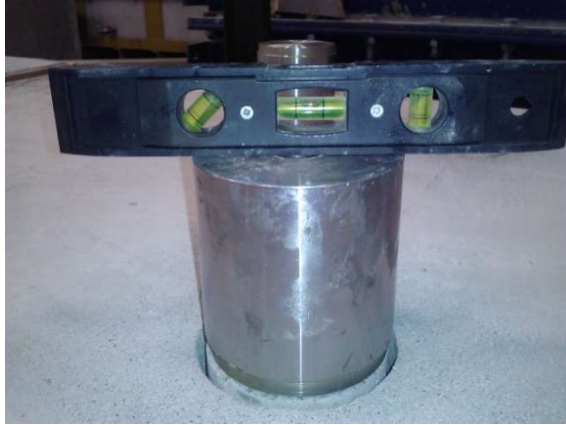
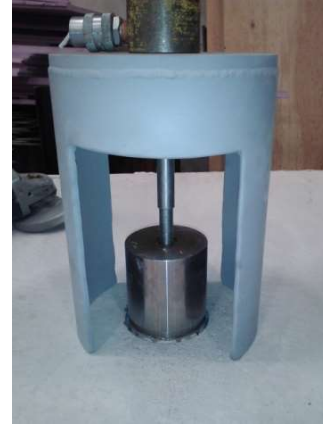
Fig. 9: Pull-off test preparation.

(a) Bonding of the steel disk using epoxy.

(b) Disk attachment to pull-off apparatus.

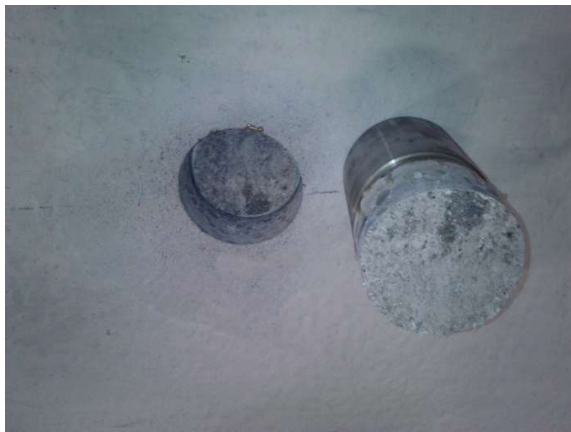
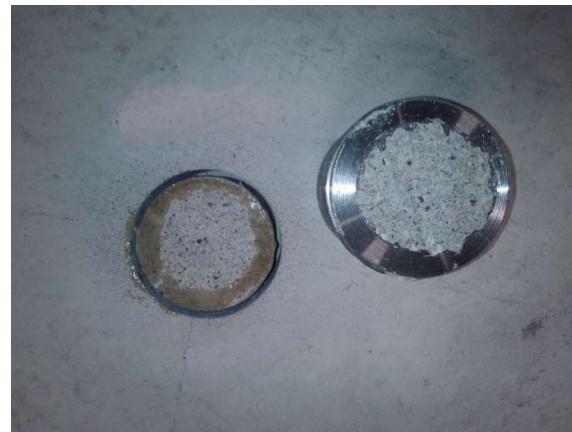
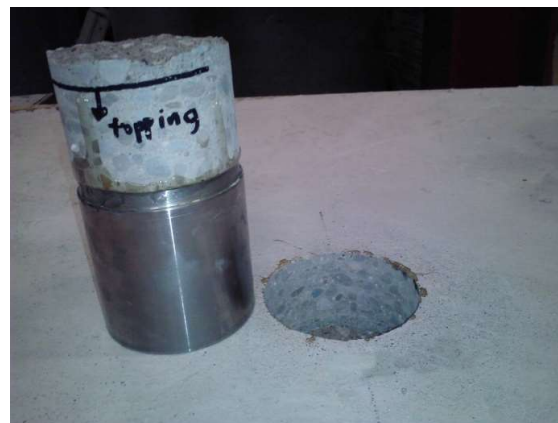
Fig. 10: Failure types.

(a) Interface failure (I).

(b) Epoxy failure (X).

(c) Hollowcore slab failure (H).

The maximum load prior to failure was retrieved from the digital load meter and recorded for each pull-off test. The weights of the steel disk, load cell, threaded rods and the hydraulic jack were deducted from the maximum load. The load was then divided by the cross sectional area of the core to obtain the bond strength at failure. The bond strength and the type of failure associated with each core are summarized in Table 5. Fig. 10 shows the different types of failure

observed during the pull-off tests. Results of 13 tests from manufacturer A and 14 tests from manufacturer B were below the 0.9 MPa limit. Slabs of 4th shipment showed poor performance (24 tests). Four of the specimens failed at the interface and did not provide any tensile resistance. Two slabs, PSMA4-2 and PSMB4-2, provided unacceptable bond strength. This can be attributed to the considerably low surface roughness for this shipment. The slabs from the other shipments showed acceptable performance except for core C1 of slab FMA2-2 and cores C1 and C2 of slab FMB2-2. This is likely because of a localized surface condition of the slab surface prior to casting of the topping. The bond between the concrete topping and the hollowcore slab surface is controlled by two mechanisms: chemical bond and mechanical bond. The later is dependent on the surface roughness. The chemical bond is affected by the moisture content of the hollowcore slab surface, which was optimized utilizing the SSD moisture condition¹³. Fig. 11 shows the pull-off test results in terms of surface roughness, where it can be observed that slabs with surface roughness higher than 0.30 mm achieved acceptable bond strength.

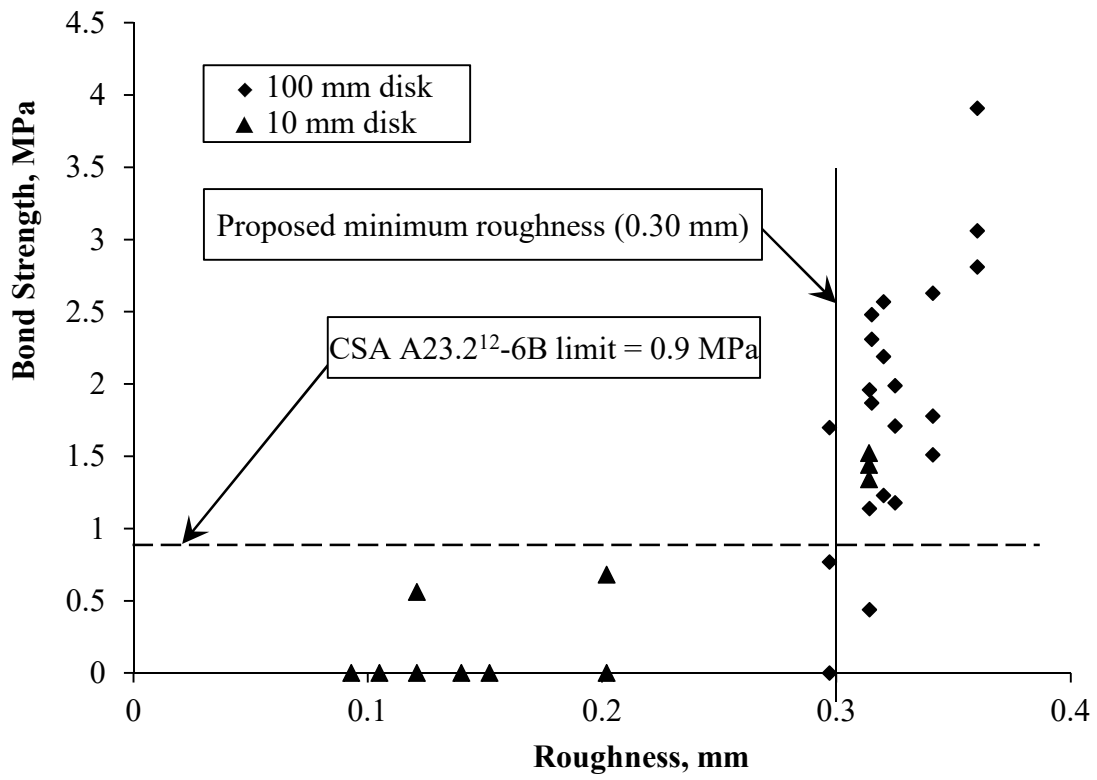
Fig. 11: Pull-off test results in terms of hollowcore slab surface roughness

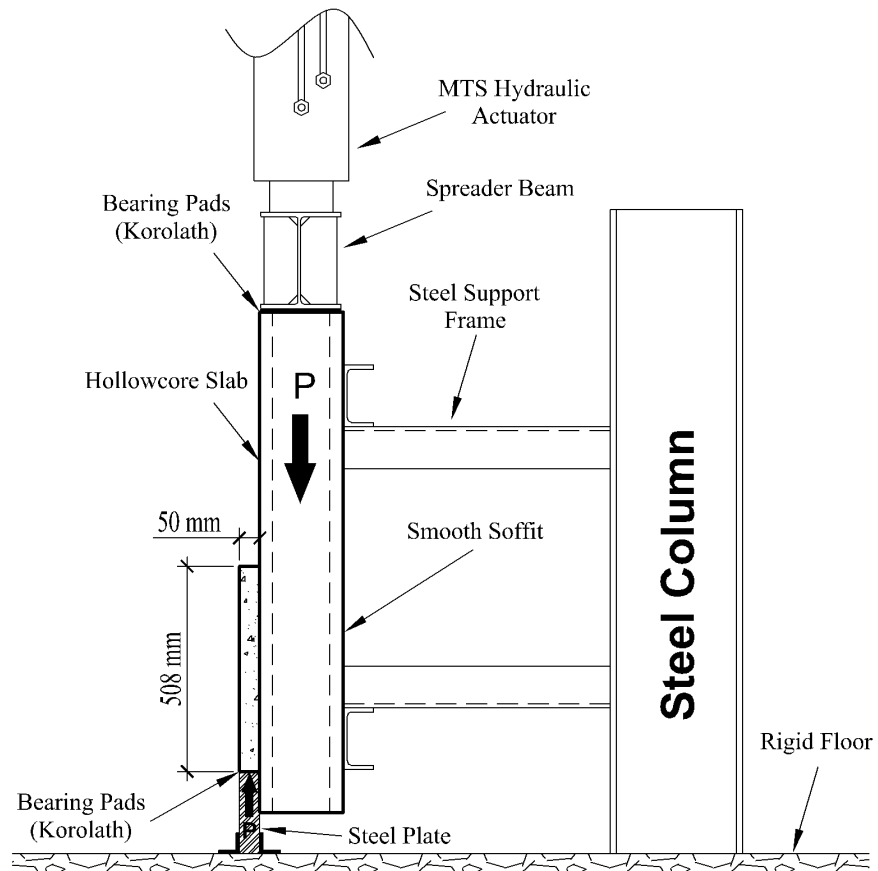
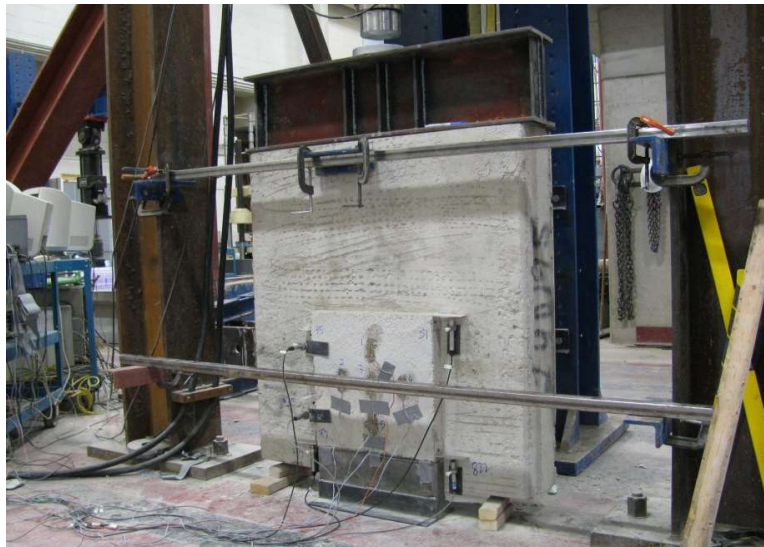
Fig. 12: Push-off test setup.

(a) Schematic.

(b) Photo.

The push-off tests were conducted in a vertical orientation to permit easier alignment of the MTS hydraulic actuator with the existing vertical support frame at the structures lab at Western University. Fig. 12 shows a hollowcore slab installed in the vertical direction with its concrete topping resting on a 50 mm thick steel plate. When a vertical force is applied using the shown MTS hydraulic actuator, a spreader steel beam distributes the force on the hollowcore slab. The steel plate then reacts with a force on the concrete topping. This force generates shear and peel stresses along the interface between the slab and the topping.

A steel frame, positioned behind the hollowcore slab, prevents the lateral movement. The soffit side of the hollowcore slab is sufficiently smooth, which allows free movement of the slab relative to the steel frame. 50 mm wide by 3 mm thick Korolath bearing pads are used under the steel spreader beam and between the steel plate and the concrete topping to guarantee a uniform stress distribution at those locations. The tests were conducted by applying the load using the MTS actuator at a rate of 10 kN per minute.

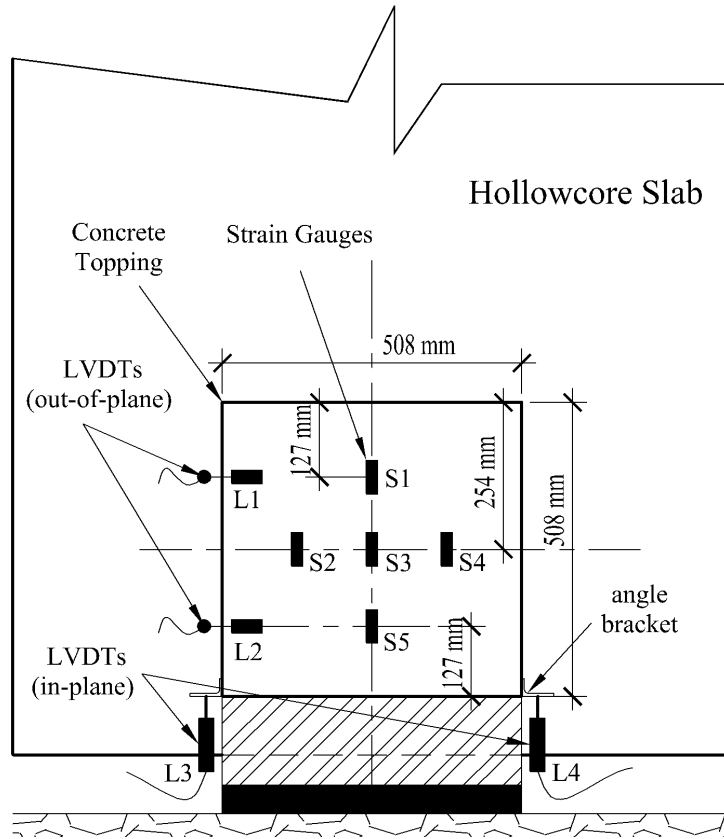
Fig. 13: Push-off test instrumentation.

To capture the state of strains in the concrete topping, five strain gauges were attached to its top surface as illustrated in Fig. 13. Strain gauges S1, S3, and S5 measured the strains in the direction of the applied load and strain gauges S2 and S4 measured the distribution of stresses across the topping width. The push-off test induced two types of stresses on the interface between the concrete topping and the hollowcore slab: (1) shear stresses (stresses parallel to the interface) and (2) peel stresses (stresses perpendicular to the interface).

Movement in the shear and peel directions were recorded using four Linear Variable Displacement Transducers (LVDTs), L1 to L4, as shown in Fig. 13. LVDTs L1 and L2 measured the peel deformations and LVDTs L3 and L4 measured the shear deformations between the hollowcore slab and the concrete topping.

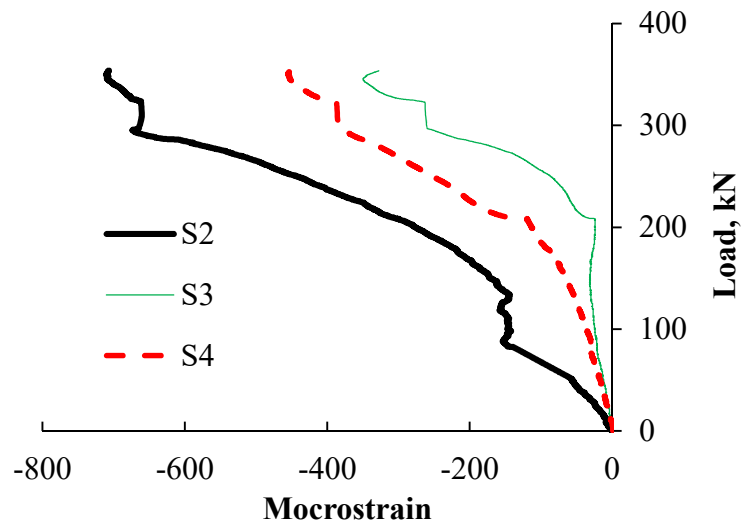
Fig. 14: Readings of strain gauges S2, S3 and S4 for SMA1-2

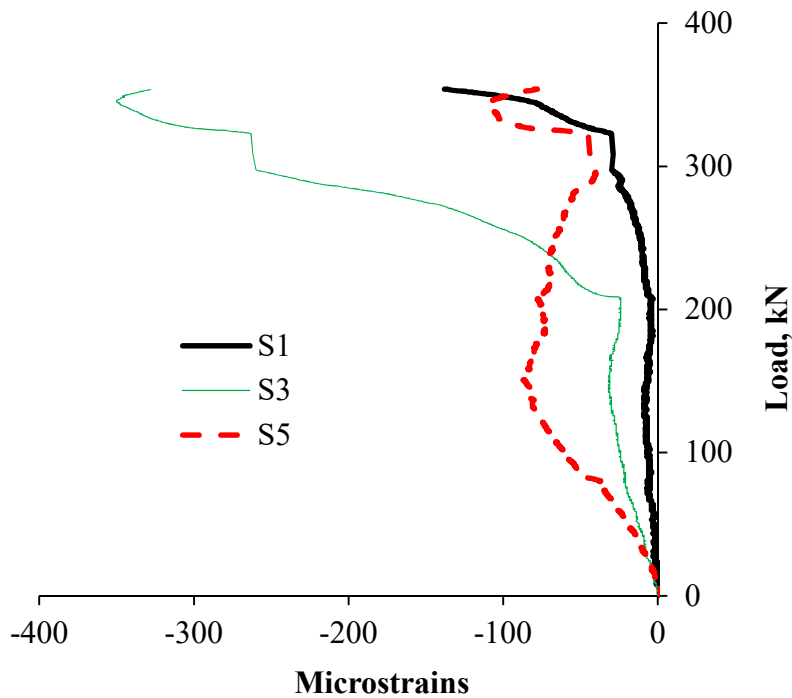
Fig. 15: Readings of strain gauges S1, S3 and S5 for SMA1-2.

The concrete strain readings from strain gauges S1, S3 and S5 are shown in Fig. 15 for slab SMA1-2. Strain gauge S5 initially recorded the highest readings. At a load level of about 200 kN, strains measured by S3 started to increase at a high rate indicating a fracture in the zone of S5. At load level of about 320 kN, readings from strain gauge S1 started to pick up. This mechanism illustrates a progressive type of failure, which is initiated by the fracture of the interface between the hollowcore slab and concrete topping at the loading end.

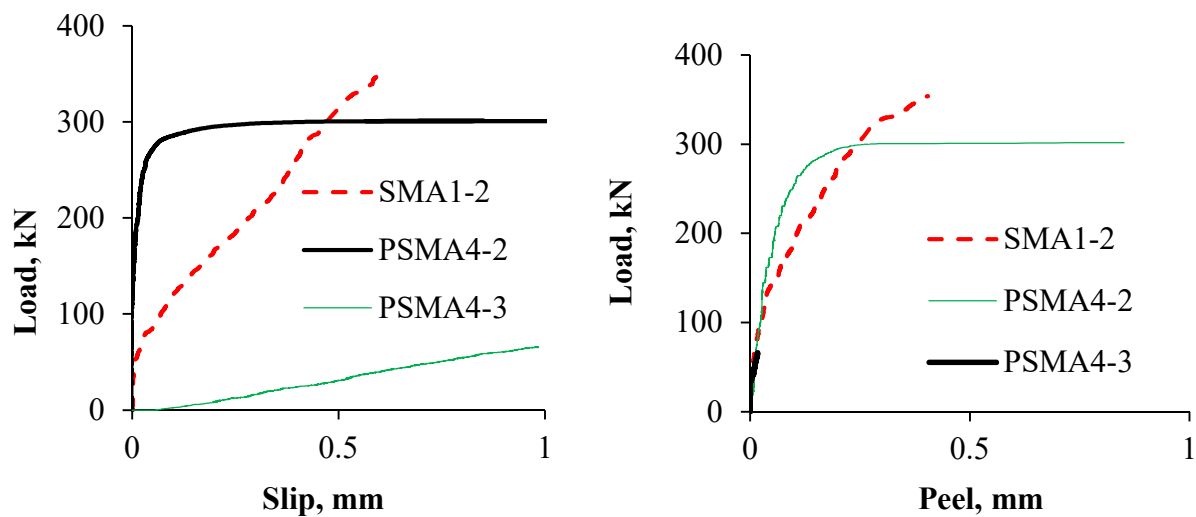
Fig. 16: Slip and peel results.

(a) Load-slip results.

(b) Load-peel.

Readings of the strain gauges gave evidence of load redistribution within the slab surface. However, extremely brittle and abrupt failure was observed because of the small recorded slips. The average slips at failure were calculated using readings of LVDTs L3 and L4 and are shown in Table 6. The load versus slip curves are shown in Fig. 16(a). The peel deformations recorded by LVDT L2 are shown in Fig. 16(b). LVDT L1 did not return any measurable readings.

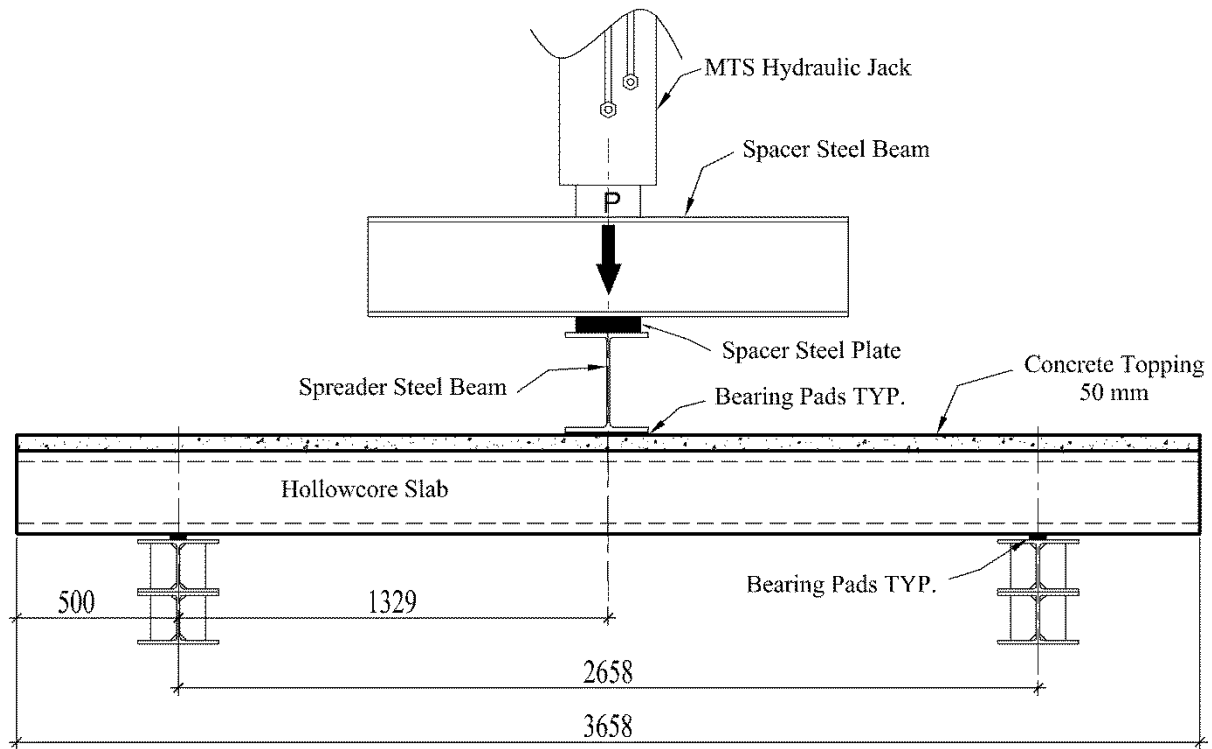
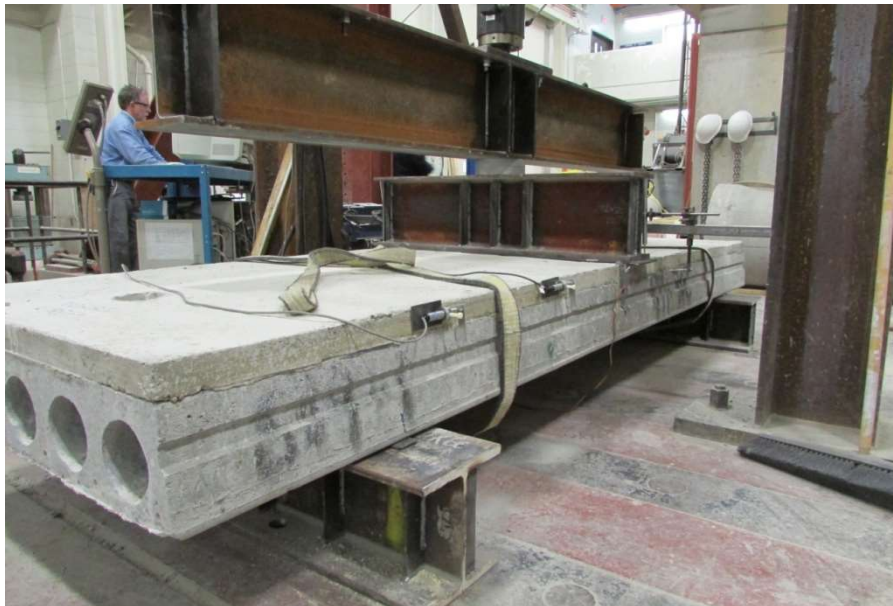
Fig. 17: Full-scale test setup.

(a) Schematic (dimensions in mm).

(b) Photo.

The full-scale tests were conducted using three-point bending as shown in Fig. 17. The total length of each slab was 3658 mm. Both slabs from manufacturer A, FMA2-1 and FMA2-2 were 254 mm deep. Slabs FMB2-1 and FMB2-2 had a thickness of 254 mm and slab FMB2-3 was 304 mm deep. The distance between the support and the point load was 1329 mm resulting in shear span ratios of 4.37 and 5.25 for the 304 mm and 254 mm slabs, respectively.

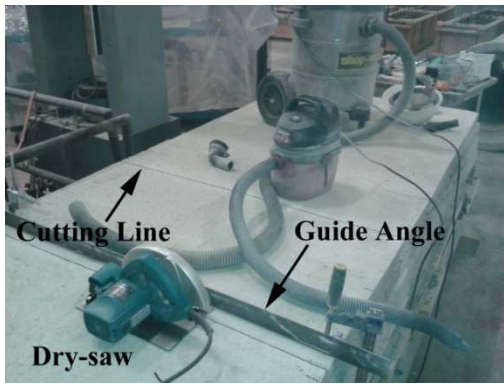
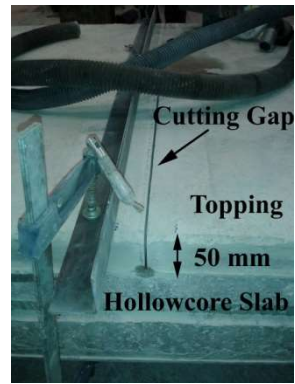
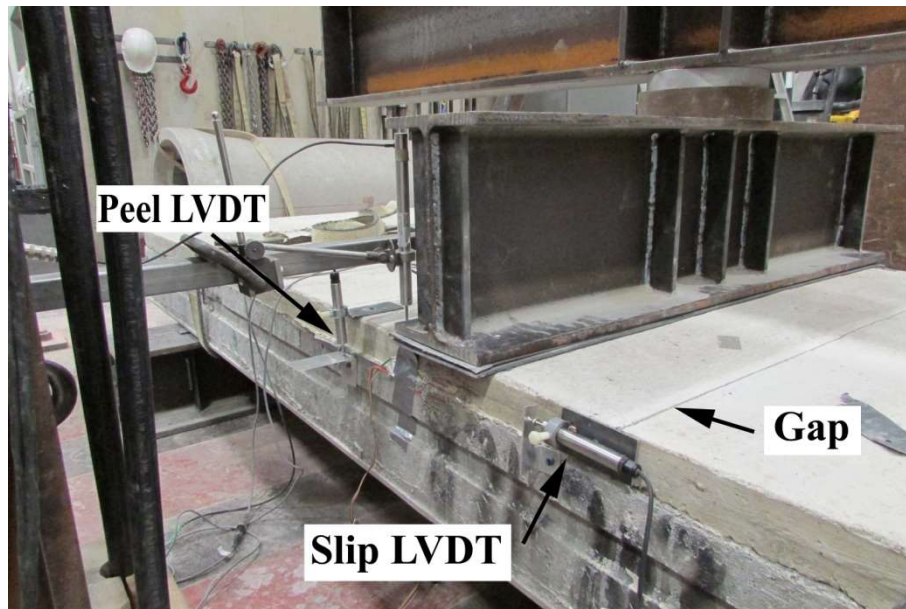
Fig. 18: Slabs with gap in their topping (FMA2-2 and FMB2-1).

(a) Saw cutting of the concrete topping.

(b) Test setup.

The contact surface was reduced for slabs FMA2-2 and FMB2-1 by inducing a separation in the concrete topping. This discontinuity in the concrete topping was achieved by saw cutting as illustrated in Fig. 18. The saw cut created a 4 mm separation gap in the concrete topping.

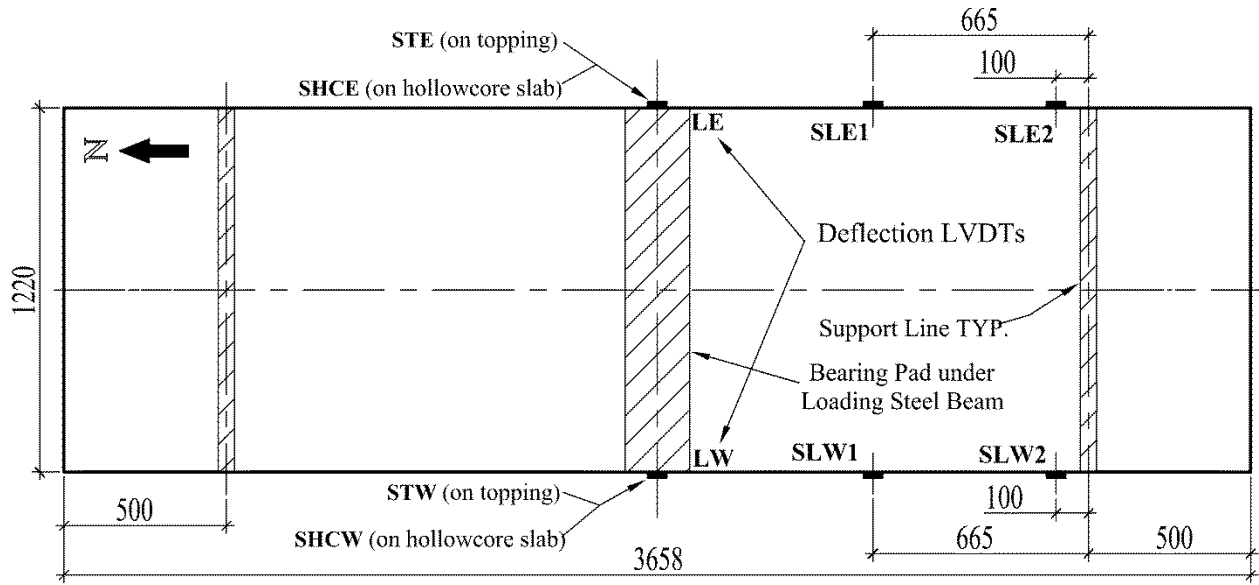
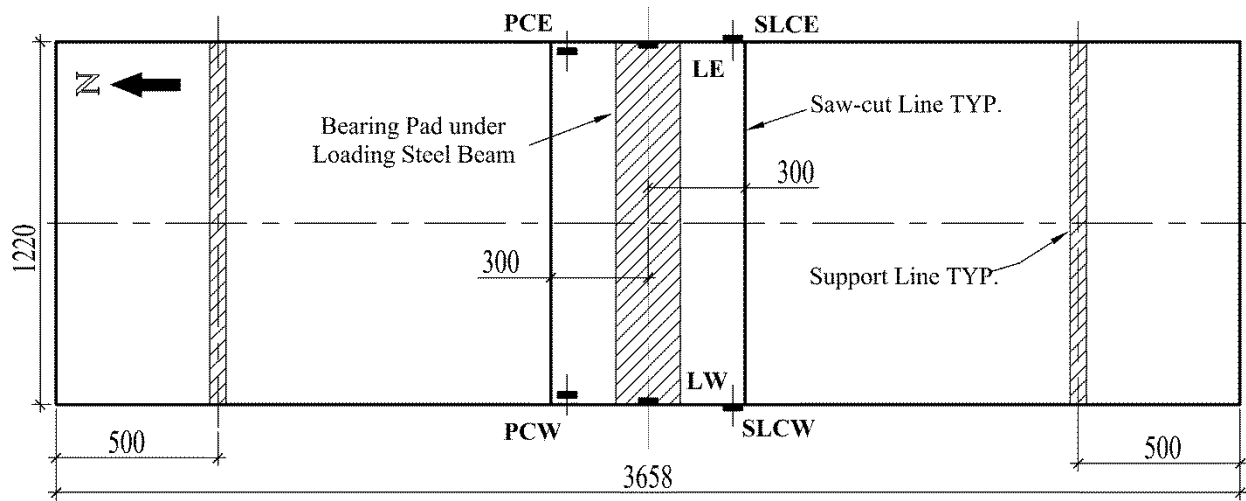
Fig. 19: Instrumentation layout (dimensions in mm).

(a) Typical slab.

(b) Slabs with gaps in their topping.

The three specimens that did not have a gap in their topping were instrumented with six LVDTs as shown in Fig. 19(a). Two LVDTs (LE and LW) located at mid-span of the slabs measured the vertical deflection. Four LVDTs measured the slip between the concrete topping and the hollowcore slab at the middle of the shear span (SLE1 and SLW1) and near the supports (SLE2

Instrumentation layout of slabs FMA2-2 and FMB2-1 is illustrated in Fig. 19(b). Two LVDTs (LE and LW) located at mid-span of the slabs measured the vertical deflection. The slip and peel deformations between the hollowcore slabs and the topping were measured using LVDTs (SLCE and SLCW) and (PCE and PCW), respectively. Four strain gauges at the midspan section were also used to monitor concrete strains. A static loading rate of 10 kN per minute was applied for all tests to accurately capture the behaviour and failure mechanism. The instrumentation data was collected through a data acquisition system every second.

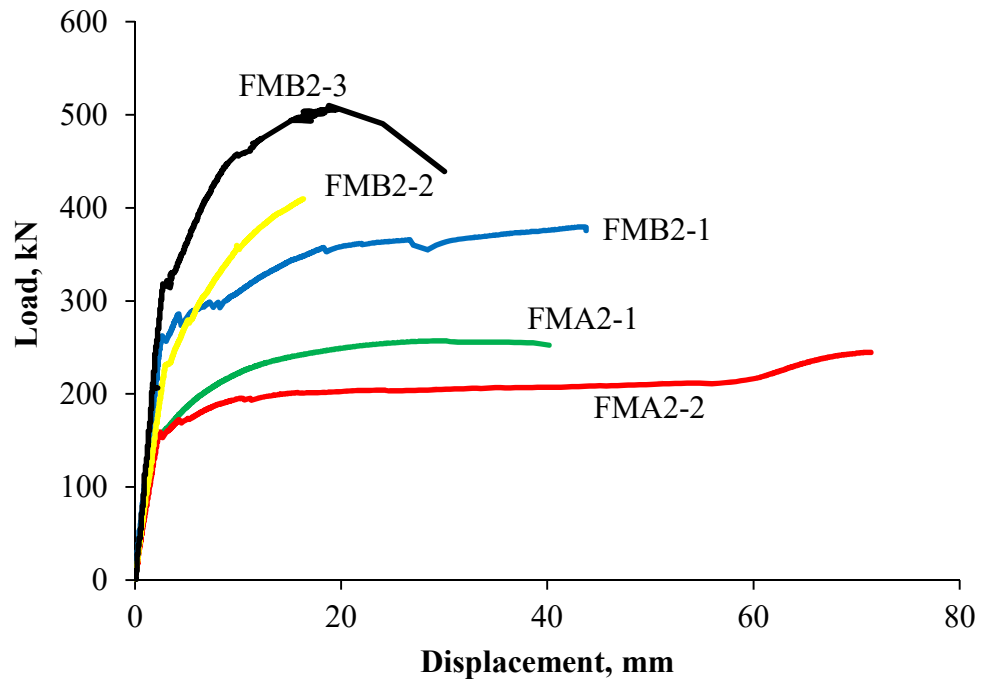
Fig. 20: Load-deflection test results.

The load-deflection graphs are shown in Fig. 20 with the deflection values calculated based on the average of LVDTs LW and LE. The load-deflection curves demonstrate typical flexural behaviour. The initial change in the load-deflection slope was caused by cracking when the tensile stress at the bottom of the hollowcore slab exceeds the cracking stress. Yielding caused additional changes in slope of the load-deflection curve. Three of the tested slabs failed in flexural shear mode, where a flexural crack had initiated and then propagated triggering shear failure. Two slabs have failed by strands rupture, FMA2-1 and FMA2-2. Fig. 21 shows the failure modes for all slabs.

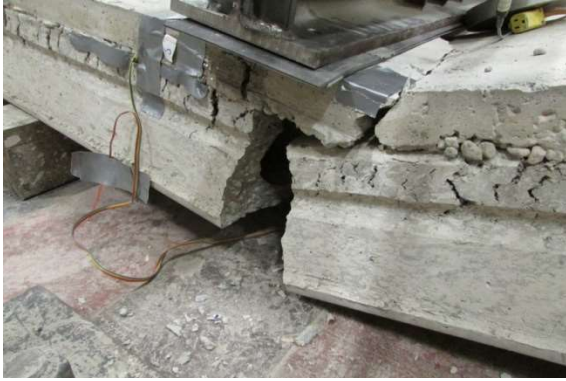
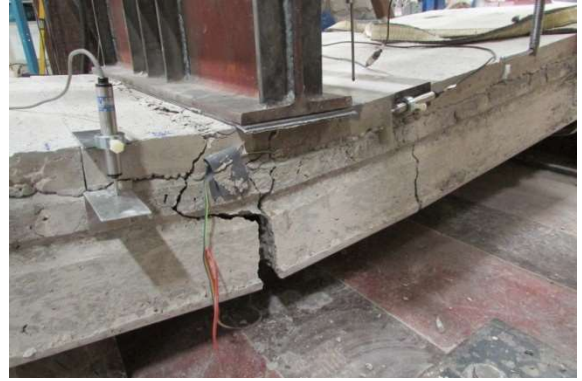
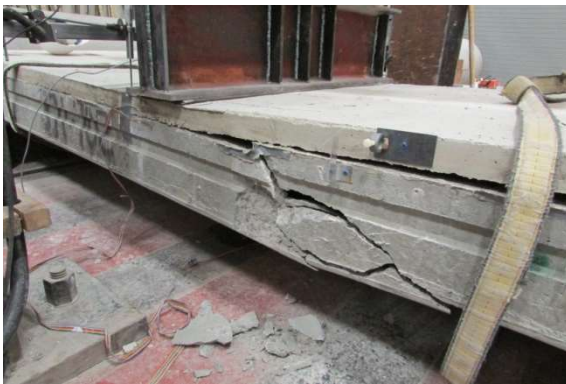
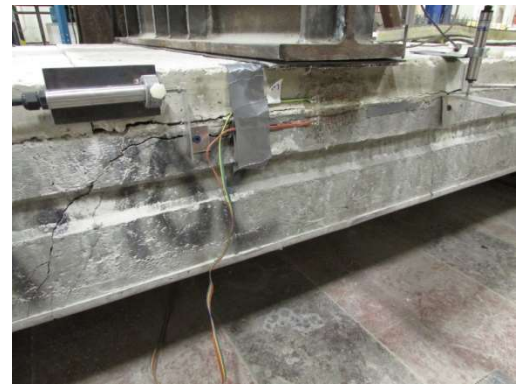
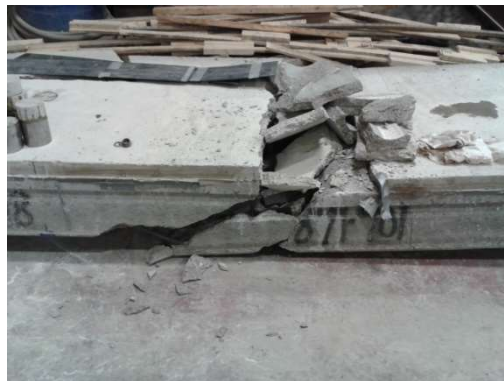
Fig. 21: Failure modes.

(a) FMA2-1 (strand rupture).

(b) FMB2-2 (strand rupture).

(c) FMB2-1 (flexural shear failure).

(d) FMB2-2 (flexural shear failure).

(e) FMB2-3 (flexural shear failure).
