EXPERIMENTAL INVESTIGATION OF THE COMPOSITE ACTION BETWEEN HOLLOWCORE SLABS WITH MACHINE CAST FINISH AND CONCRETE TOPPING

Aiham Adawi¹, Maged A. Youssef^{*,1}, Mohamed E. Meshaly²

¹ Department of Civil and Environmental Engineering, Western University, London, Ontario, Canada, N6A 5B9

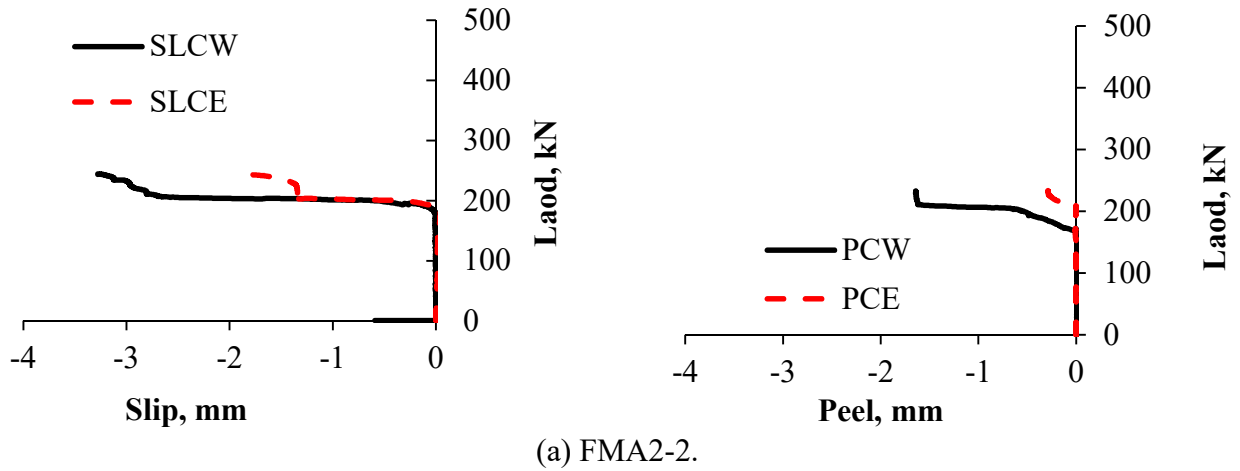
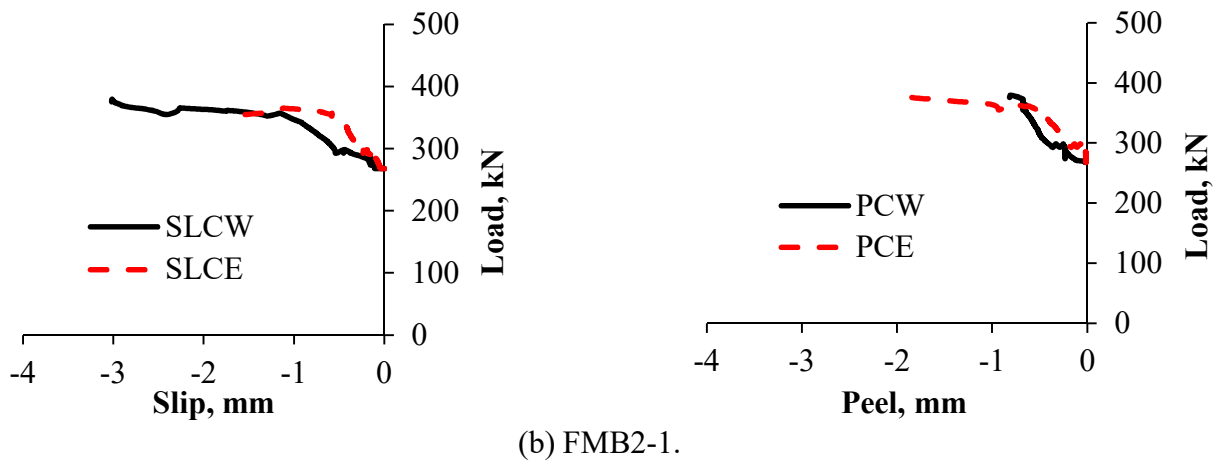
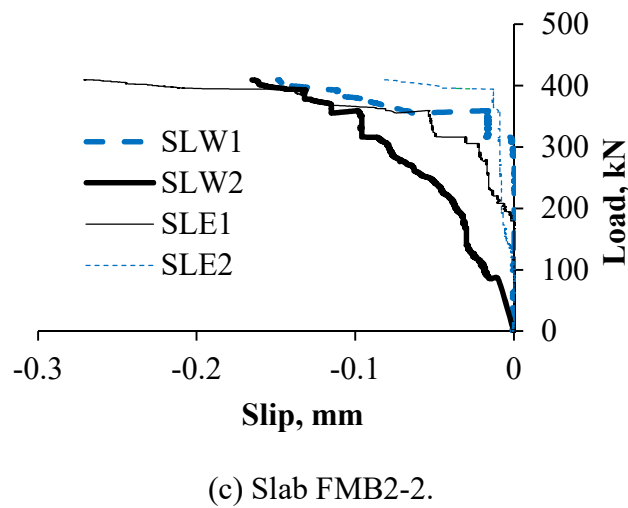
Fig. 22: Slip and peel measurements.

Careful inspection of the slip and peel curves for the two slabs that had gaps in their topping illustrated consistency between peel and slip readings. The slip values for specimen FMA2-2 show an initial high horizontal shear stiffness that is significantly reduced at a load of about 186

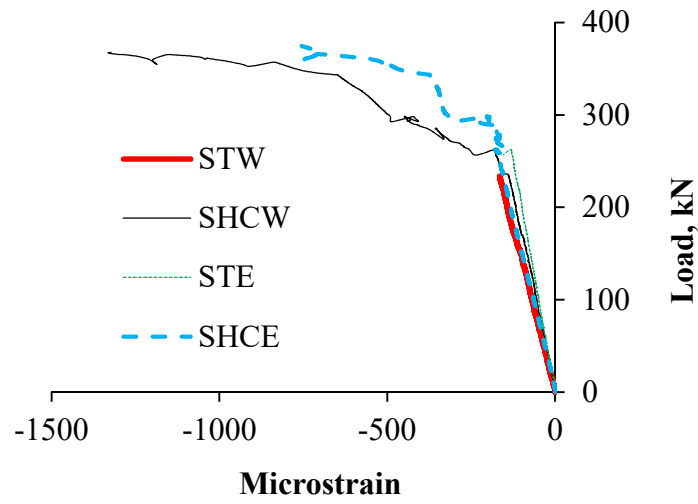
Fig. 23: Strain readings for FMB2-1.

kN. This might be due to loss of the bond resistance at the interface. The slippage measured at the west side was higher than that measured at the east side. This is clearly linked to the peel deformations that show higher values at the west side than the east side. Same observations can be made about slab FMB2-1. Strain readings for slab FMB2-1 are shown in Fig. 23. Near failure, bond between the concrete topping and the hollowcore slabs was weakened, which triggered slip along the interface and caused the compressive stresses in the concrete topping to unload and the tensile strains in the top of the hollowcore slab to unload and change to compressive strains.
