## 1 **1. Introduction**

14 The present paper reports the results of an experimental study that investigates the effects of using  
15 SE SMA bars as reinforcement on the seismic performance of exterior BCJs, as well as on their  
16 seismic behaviour after repair. The BCJ specimens have been designed and constructed according  
17 to current seismic design standards (NBCC 2005, and CSA A23.3-04), and tested under reversed  
18 cyclic loading. The prime objective of this study is to develop a smart concrete BCJ reinforced with  
19 SE SMA in its plastic hinge region and investigate its performance under reversed cyclic loading  
20 when intact and after repair, and then compare the behaviour of the original to that of the repaired  
21 specimen in terms of load-displacement, energy dissipation capacity, and strains in the longitudinal  
22 and transverse reinforcements.

### 11 **3. Details of Specimens**

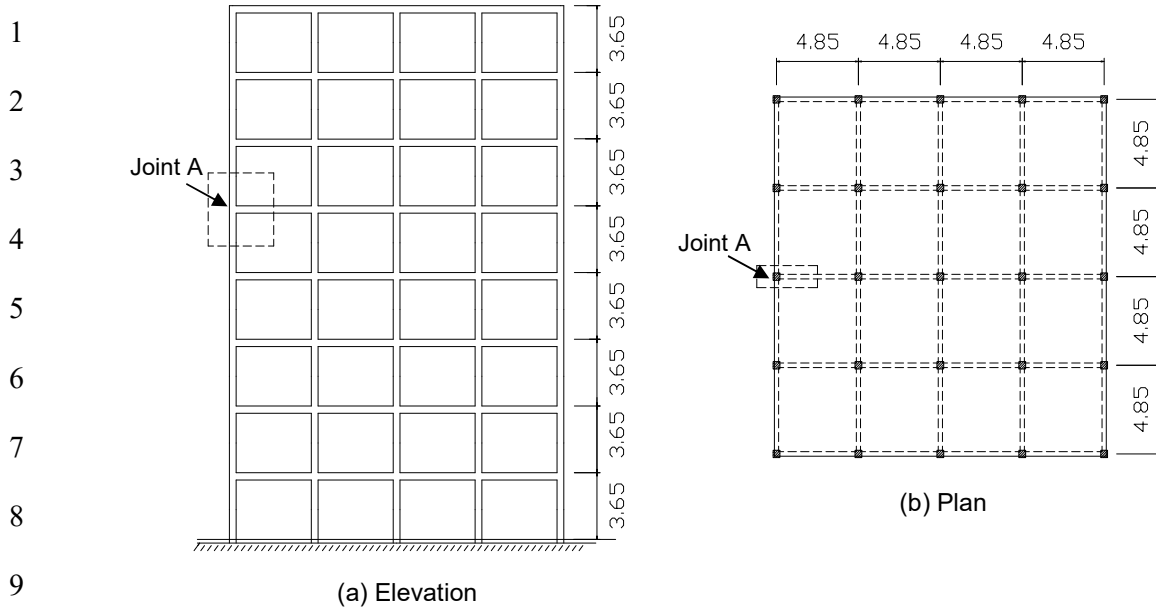
**Fig. 1 – Eight-storey frame building located in the western part of Canada (dimensions in meters; 1 m = 39.37 in).**

19 An eight-storey RC building with moment resisting frames was designed and detailed in accordance  
20 with Canadian Standards (CSA A23.3-04). The building was assumed to be located in the western  
21 part of Canada on firm ground with un-drained shear strength of at least 100 kPa. The elevation and  
22 plan of the building are shown in Fig. 1. The moment frames were designed with a moderate level  
23 of ductility. An exterior beam-column joint was isolated at the points of contra-flexural, from the  
24 mid-height of the fifth floor to the mid-height of the sixth floor (Joint A in Fig. 1).

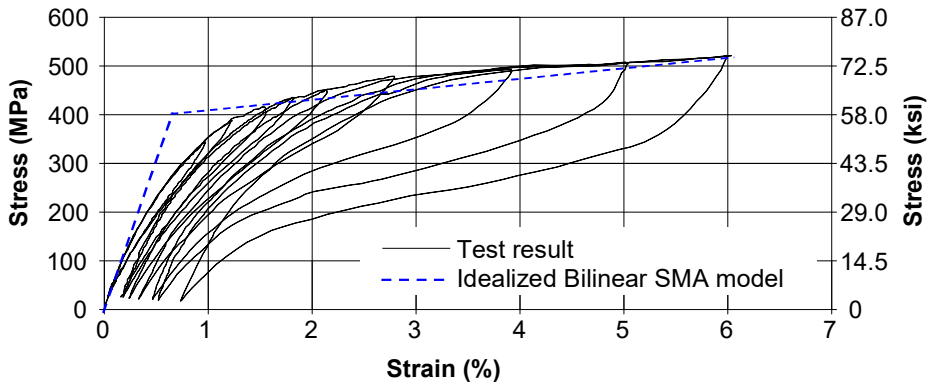
Fig. 5 – Cyclic tensile strength of SE SMA rebar within couplers.

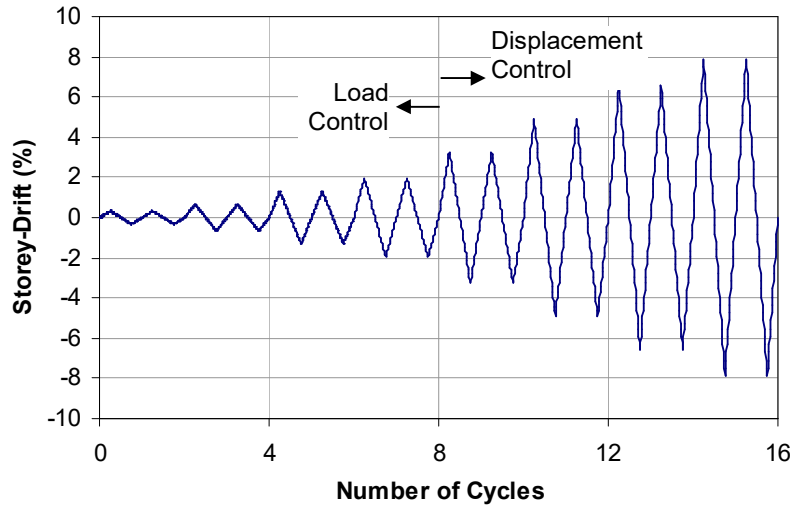
Fig. 6 – Load history for the reversed cyclic load test.

14 displacement,  $\Delta_y$ , were recorded. After yielding, displacement-controlled loading was applied in the  
15 form of incremental multiplies of the yield displacement,  $\Delta_y$ . For each load cycle, the test specimen  
16 was subjected to two complete cycles to verify its stability. Tests were conducted up to a storey drift  
17 of 7.9% (Fig. 6), which is more than double the collapse limit as proposed by Elnashai and  
18 Broderick (1994).

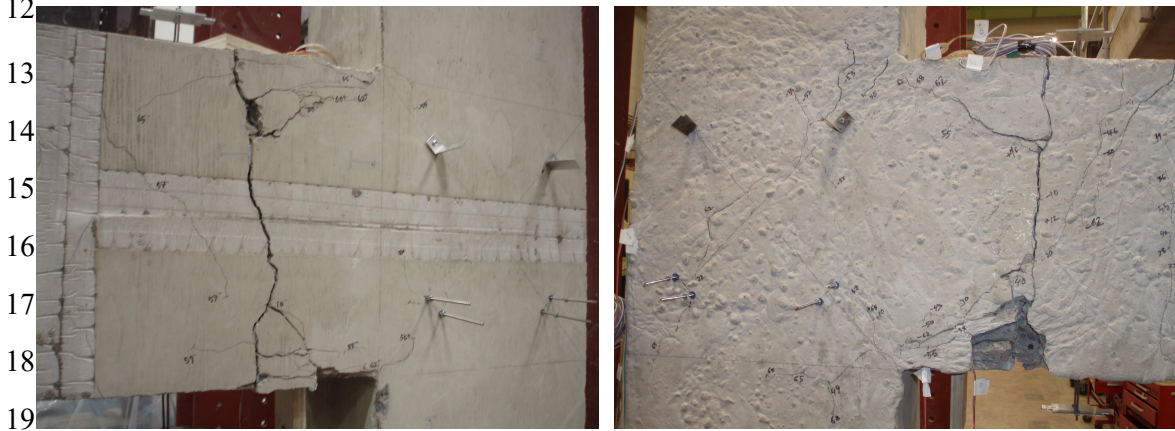
Fig. 9 – Crack pattern of specimens after being subjected to cycles up to 72 mm (2.83 in): (a) front face of JBC-2; and (b) rear face of JBC-2.

10 later closed to a width of less than 1 mm (0.04 in). Several existing flexural cracks in the beam  
11 extended to its full depth parallel to the column face. At a deformation level of  $4\Delta_y$ , the cracks  
12 became wider in the plastic hinge area of the beam. The FFC opened up to 10.7 mm (0.42 in) during  
13 the loading cycle, and part of the bottom concrete cover spalled off. At the end of this cycle, the  
14 residual FFC crack width was 2.2 mm (0.09 in), whereas all other cracks in the beam had very small  
15 width. The joint region exhibited few diagonal cracks of very fine width and small length, and  
16 remained almost fully intact. Figure 9 shows the crack pattern of JBC-2.

11 dissipate an almost equal amount energy to that of the original specimen, JBC-2. However, the level  
12 of damage of the cover concrete in JBC-3 was relatively larger in the beam hinge region (Figs. 9  
13 and 12) than that of JBC-2.

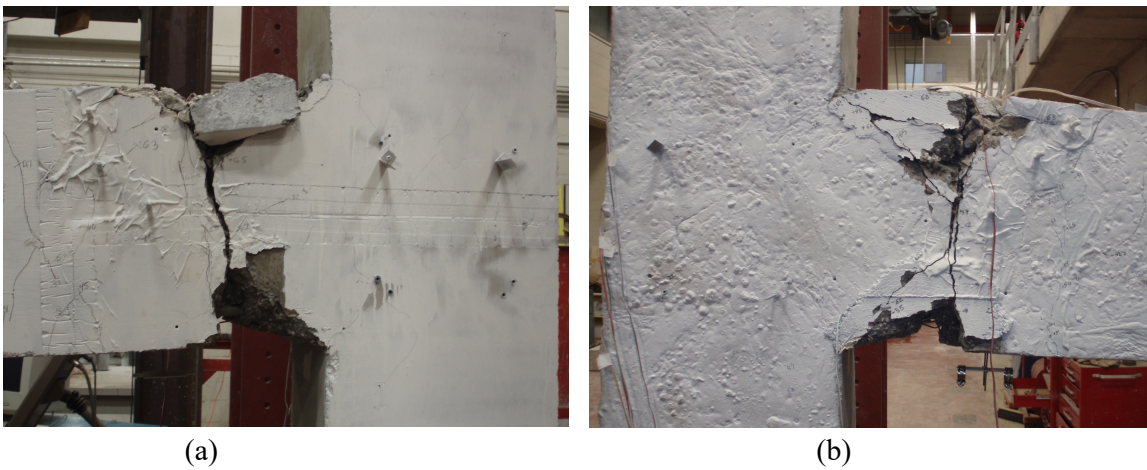
Fig. 12 – Crack pattern of specimens after being subjected to cycles up to 72 mm (2.83 in): (a) front face of JBC-3; and (b) rear face of JBC-3.

20 became 19 mm (0.75 in) wide whereas the bottom experienced a 16 mm (0.63 in) wide crack. At  
21 this stage, some concrete cover from the top and bottom part of the beam started to spall off and the  
22 stirrups at the repaired section became visible. Throughout the test, the axial load of the column was  
23 maintained and the joint area remained fully undamaged apart from a few hairline cracks (Fig. 12).

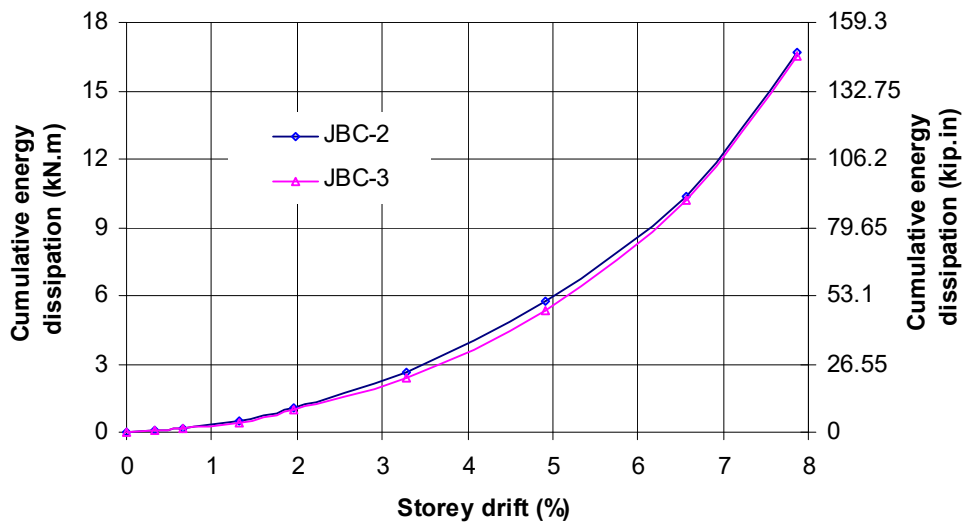
Fig. 15 – Cumulative energy dissipation–storey drifts relationship of specimens JBC-2 and JBC-3.

1 The cumulative energy dissipation by the beam-column joint specimens during reversed cyclic  
2 loading was calculated by summing up the dissipated energy in successive load-displacement loops  
3 throughout the test. The cumulative energy dissipation with respect to storey drift for specimens  
4 JBC-2 and JBC-3 is presented in Fig. 15. JBC-3 dissipated 2.0 kN.m (1.48 kip.ft) of energy at a  
5 storey drift of 3% (collapse limit as defined by Elnashai and Broderick 1994), which is 11.5%  
6 smaller than that of JBC-2 at the same amount of drift. The amount of energy dissipated at 4%  
7 storey drift for JBC-2 is equivalent to the amount of energy dissipated by JBC-3 at a storey drift of  
8 4.2%. At a storey-drift of 7.9%, JBC-2 was found to absorb 16.7 kN.m (12.32 kip.ft) of energy,  
9 whereas JBC-3 dissipated 16.5 kN.m (12.18 kip.ft) of energy at the same storey-drift, which is only  
10 1.2% smaller than that of JBC-2. Thus, it is evident that the repaired specimen JBC-3 could

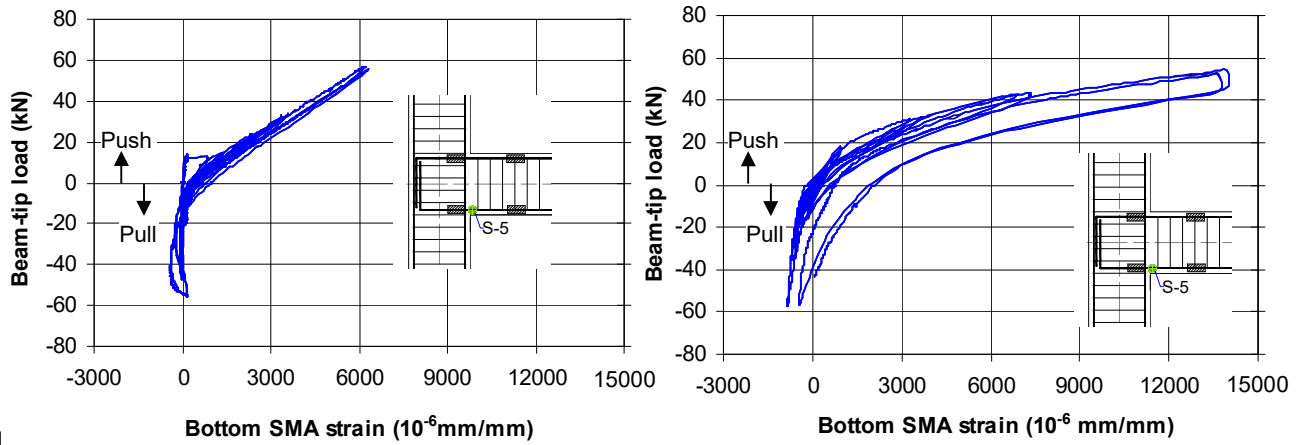
(a) JBC-2; and (b) JBC-3.

16 Strains were measured in longitudinal and transverse reinforcing bars. Figures 16 (a) and (b) show  
17 the measured strains in the main bottom reinforcing SMA rebar at the plastic hinge region, close to  
18 the column face of specimens JBC-2 and JBC-3, respectively. Figure 16 (b) shows that specimen  
19 JBC-3 suffered a higher residual strain in the SMA bar compared to that of JBC-2 (Fig. 16 (a)). This  
20 accumulation of residual strain resulted from repetitive cycles of loading. For specimen JBC-2 the  
21 measured strain in the main steel reinforcing bar inside the joint varied from +1156 to -86 micro-  
22 strains (absolute range: 1242 micro-strain, Fig. 17 (a)), whereas the steel reinforcing bar inside the  
23 joint of specimen JBC-3 experienced +611 to -697 micro-strains (absolute range: 1308 micro-strain,  
24 Fig. 17 (b)). The measured strain in the transverse reinforcement inside the joint of JBC-2 varied

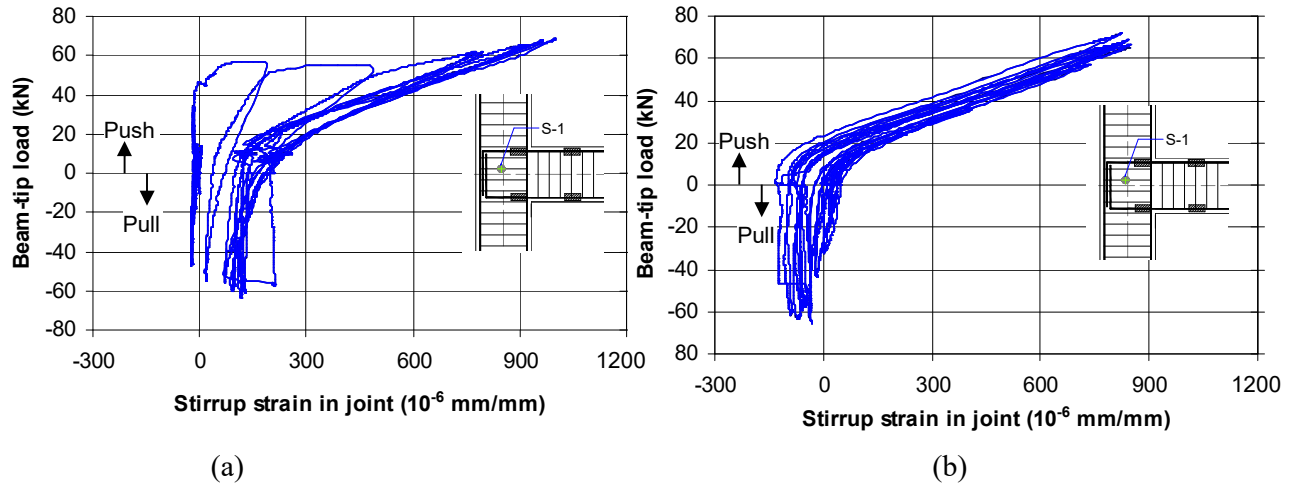
**Fig. 18 – Strains in transverse reinforcement inside the joint of specimens: (a) JBC-2; and JBC-3.**

25 from +990 to -24 micro-strains (range: 1014 micro-strain, Fig. 18 (a)), while the corresponding  
26 values for specimen JBC-3 were +848 to -132 micro-strains (range: 980 micro-strain, Fig. 18 (b)).

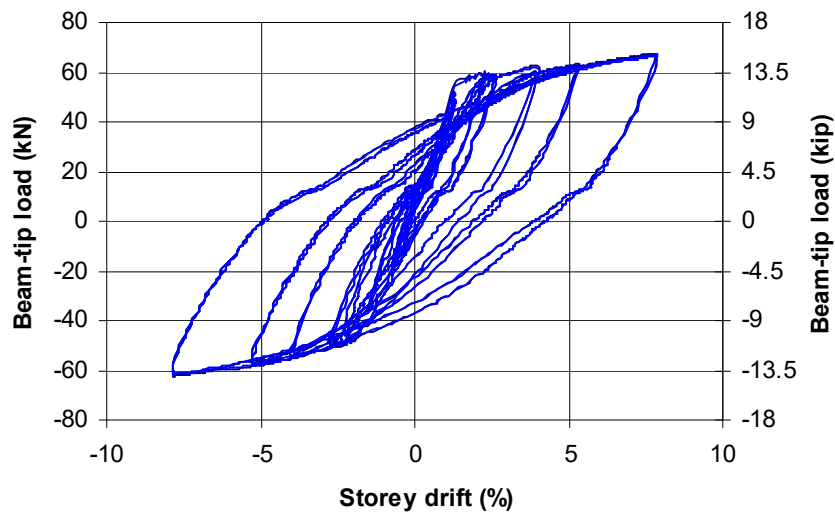
**Fig. 19 – Beam-tip load-storey drift relationship of JBC-1 (Youssef et al. 2008).**

9 Youssef et al (2008) tested a  $\frac{3}{4}$ -scale steel RC beam-column joint (JBC-1) under reversed cyclic  
10 loading, which had similar dimensions and reinforcement arrangements and was subjected to  
11 similar drifts to those of JBC-2 and JBC-3. Figure 19 shows the load-storey drift relationship of  
12 JBC-1 and Table 2 presents various performance parameters of JBC-1 in comparison to those of  
13 JBC-2 and 3. The result shows that it had similar load carrying capacity to those of JBC-2 and JBC-  
14 3, which is 1.7% and 6.1% smaller compared to that of JBC-2 and JBC-3, respectively. However,  
15 JBC-1 suffered much larger residual drift (average 4.43%), compared to those of JBC-2 (average  
16 1.42%) and JBC-3 (average 1.36%) after 8% drift. Due to larger hysteretic curves, JBC-1 dissipated  
17 37% and 38% higher energy compared to that of JBC-2 and JBC-3, respectively. In case of JBC-1,
