THE EFFECTS OF DEEP EXCAVATIONS IN SOILS AND ROCK ON ADJACENT STRUCTURES

(The R M Hardy Address)

K.Y. Lo
GRC Director and Professor Emeritus
The University of Western Ontario, London, ON, Canada

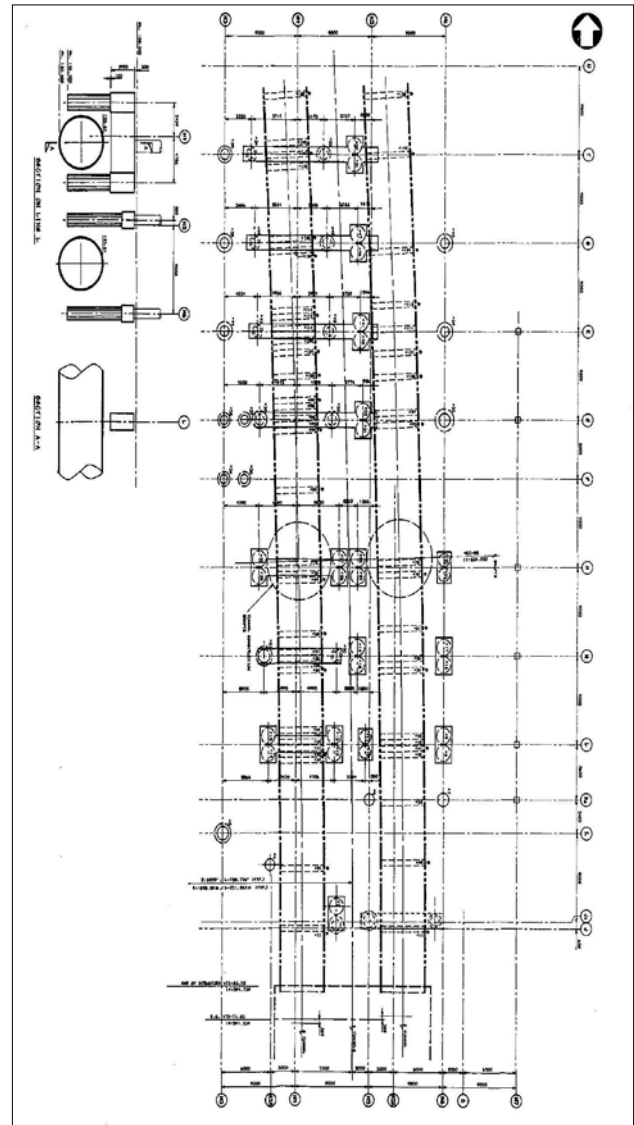
Figure 1 shows the foundation layout over the TTC subway tunnels. To eliminate the net structural loading onto the tunnels the loads were transferred to the subsoil below the invert by caissons of 1.1 to 2.4 m diameters, straddling the tunnels. The design and construction issues were therefore to minimize the effect of excavation for the substructure so as to satisfy the structural and operational requirements of the subway tunnels.

Figure 1. Plan of excavation and foundation layout- York Mills Centre

Complications in analyses and interpretation also arise because excavation was continuing at the south portion (south of column line M in Figure 1) with permission of the engineers, so as not to delay construction. In principle, therefore, for any given profile of final excavation, the predicted displacements (and other relevant quantities) should be considered in the following manner:

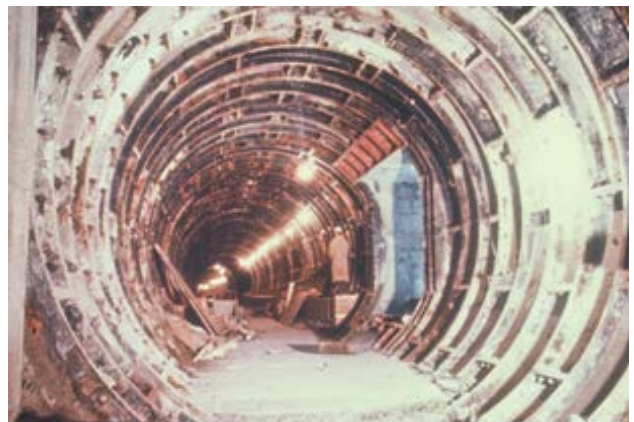
Figure 2. TTC Subway tunnel

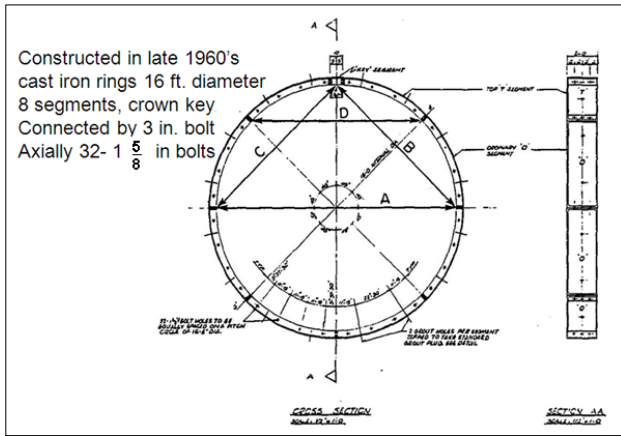
Figure 3. Detail of cast-iron segmental lining of TTC subway

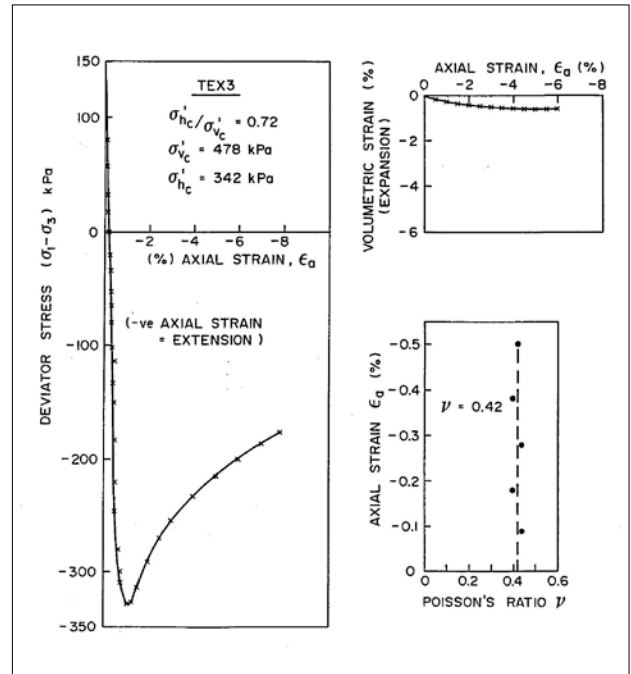
Typical results of a triaxial extension test are shown in Figure 4. It may be seen that the initial portion of the stress-strain curve is linear up to at least 0.4% axial strain. The strain at failure is approximately 1%. The sample dilates during shear but the volumetric strain is small. The Poisson's ratio is 0.42 in this test.

Figure 4. Typical results of anisotropically consolidated drained triaxial extension test

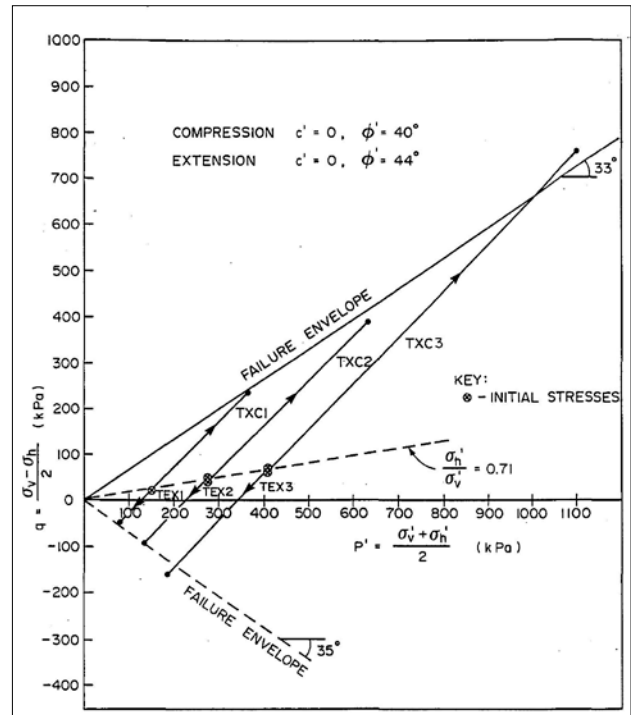
Figure 5. Failure envelope of triaxial compression and extension tests

The strength envelope for the compression and extension tests are shown in Figure 5. The samples were anisotropically-consolidated to an effective stress ratio of

$\sigma'_h / \sigma'_v = 0.7$. For design purpose, the effective stress parameters were taken to be $c' = 0$, $\phi' = 40^\circ$.

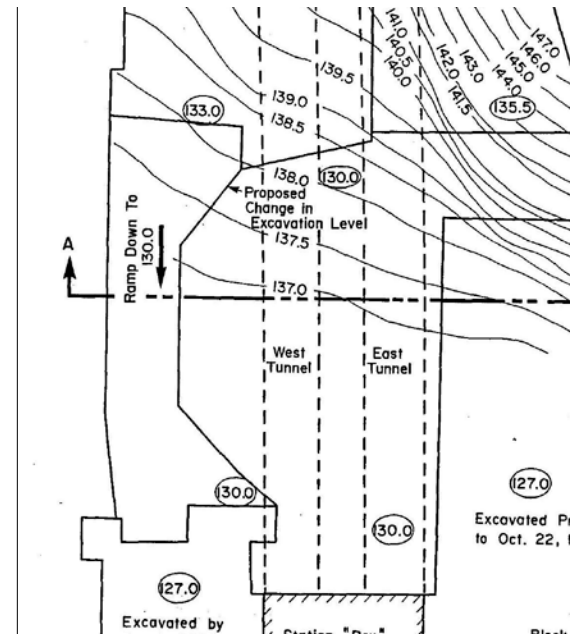
The proposed excavation in plan, as of December 1987, is shown in Figure 6.

Figure 6. Plan showing final excavation levels (proposed as of December 1987)

However, it may be seen from Figure 6 that the critical areas for both transverse and longitudinal analyses are north of column line M, so that items (2) and (3) are almost identical in these areas.

(i) in the transverse direction, a plane strain elastoplastic finite element analyses were performed on the chosen critical section A-A on Figure 6 and is illustrated in Figure 9;

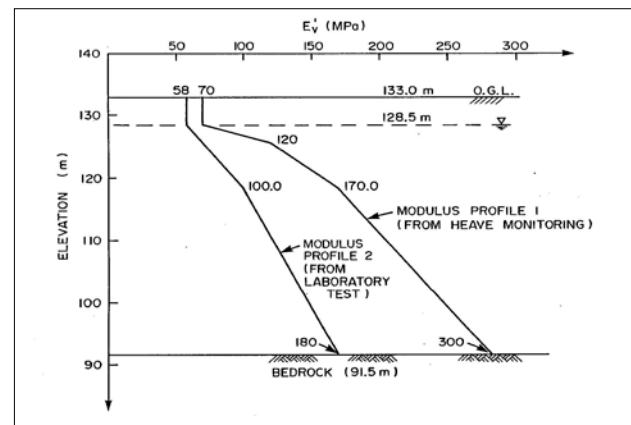
In the second stage, block samples were recovered at the location of the south-east portion of the excavation already completed. Typical results of drained extension tests, shown in Figure 4 were employed to obtain the distribution of modulus with depth. Finally, advantage was taken of the on-going excavation west of the Don Mills subway station (see Figure 6) to install instruments for heave monitoring. At locations P1 and P2, magnetic extensometers were installed and the heaves at six different depths were measured as local excavations were carried out in this area. No de-watering is allowed within the zone of influence of the heave monitoring area, to ensure that the heave measurements were not affected. The results of these measurements are shown in Figure 7.

Figure 7. Distribution of unloading modulus with depth

The soil parameters, based on laboratory test results are shown in Table 1. The two soil deformation modulus profiles in Figure 7 were employed, but design decisions were based on the profile evaluated from heave measurement.

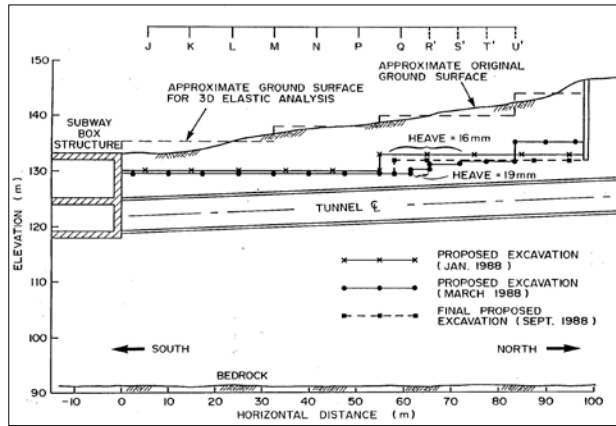
During the course of design, however, the geometry and depths of excavation were changed several times. The final longitudinal section adopted, together with two other proposals analyzed, is shown in Figure 8.

Figure 8. Longitudinal section of proposed excavations along tunnel

The results of analyses indicated that the proposed excavation with the final profile shown in Figure 8 was technically feasible without causing undue distress to the lining and it was decided that the construction would go ahead with a monitoring program to verify the design assumptions and construction control.

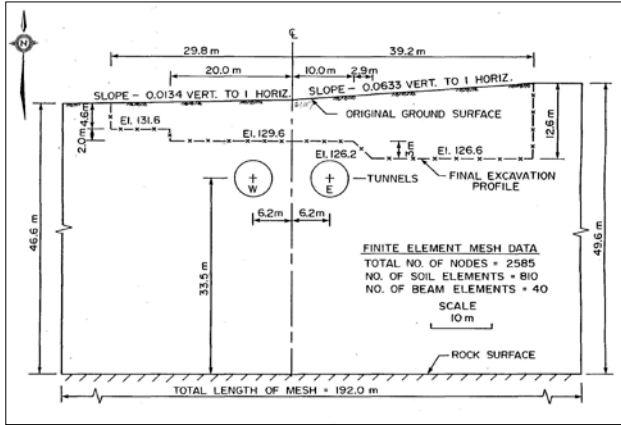
Figure 9. Condition modelled in transverse finite element analysis

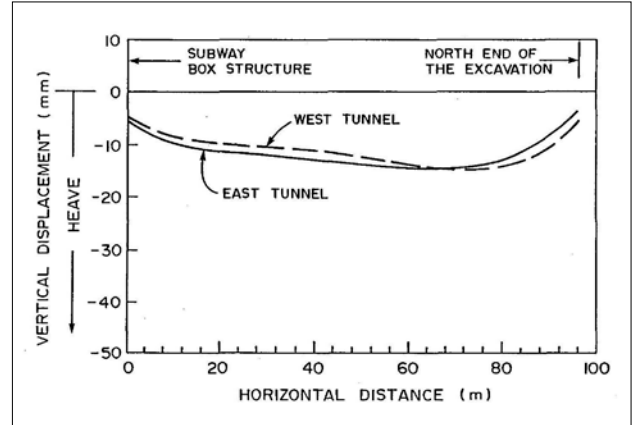
Figure 12. Predicted displacement profile of east and west tunnels after general excavation

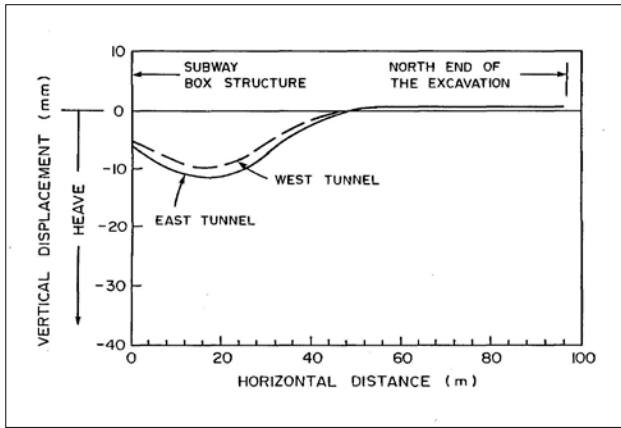
The predicted longitudinal deflection of the east and west tunnels at different stages are shown in Figure 10 to Figure 12. Further details of analysis and interpretation of analysis results may be found in Lo and Ramsay (1991).

Figure 10. Predicted displacement profiles of the east and west tunnel for the area excavated prior to December 1, 1987 – prior to monitoring

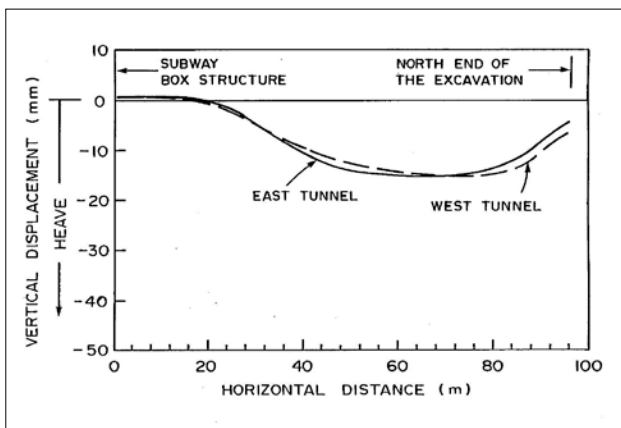
Figure 11. Predicted additional displacements along the east and west tunnels due to proposed additional excavation

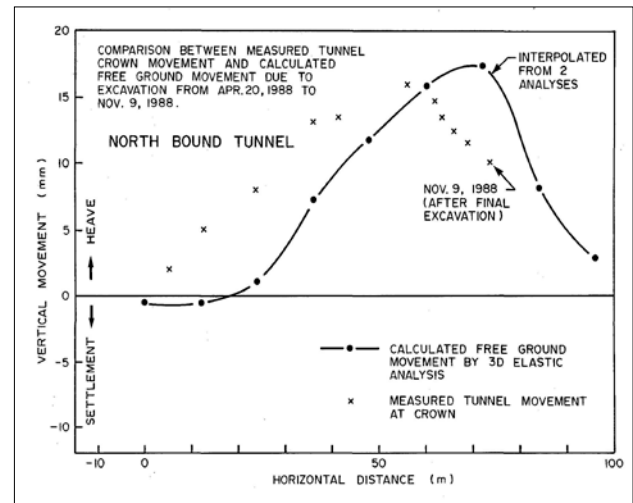
In the longitudinal direction, the deflections predicted for the northbound and southbound tunnels are compared with results of monitoring in Figure 13 and Figure 14 respectively. It can be seen that the maximum heaves measured were slightly below those predicted for both tunnels. It may be observed that the design criterion for heave was satisfied.

Figure 13. Comparison between predicted and measured heaves – northbound tunnel

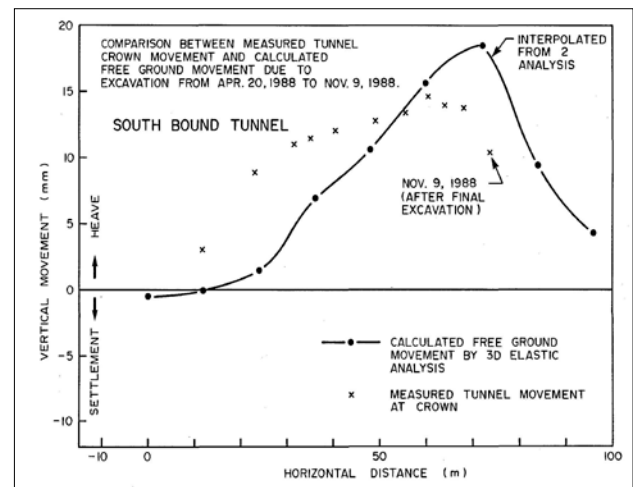
Figure 14. Comparison between predicted and measured heaves – southbound tunnel

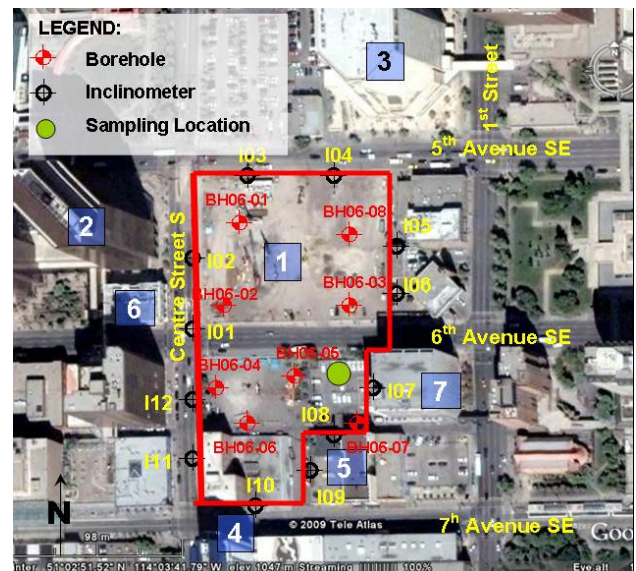
The excavation for the construction of the Bow office tower involved two city blocks. It covers a footprint of 17,000 m², 190 m long, 100 m wide and 21 m deep. It covers a footprint of 17,000 m², 190 m long, 100 m wide and 21 m deep. As shown in Figure 15, a number of

structures exist at close proximity to the excavation. These structures include the Telus building in the north, the Calgary Light Rail Transit in the south, the Petro-Canada Centre in the west, the Andrew Davidson building and the historic Royal Canadian Legion No. 1 building in the south-east side.

Figure 15. The Bow site: (1) The Bow; (2) Petro-Canada Centre; (3) Telus; (4) Calgary's Light Rail Transit; (5) The Royal Canadian Legion No. 1; (6) Chamber of Commerce and (7) Andrew Davidson Building (modified from Lo et al. 2009)

To obtain the required strength and deformation parameters, block samples were recovered from the bottom of the excavation at the location shown in Figure 15. The highly fissile nature of the mudstone rendered both sampling and preparation of specimen for triaxial and shear box tests very difficult. Nonetheless, adequate test results were obtained for the on-going analysis and excavation process.

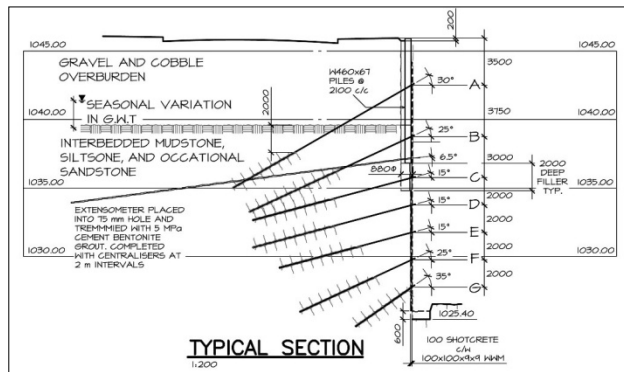
Figure 16. The Bow excavation –typical section

The caisson wall was 800 mm in diameter interlocking with soldier piles set between two filler piles. The general arrangements of the anchors are shown in Figure 16. Details of the anchor capacities are shown in Table 6. It should be noted anchors were added whenever required during construction when impending problems became evident.

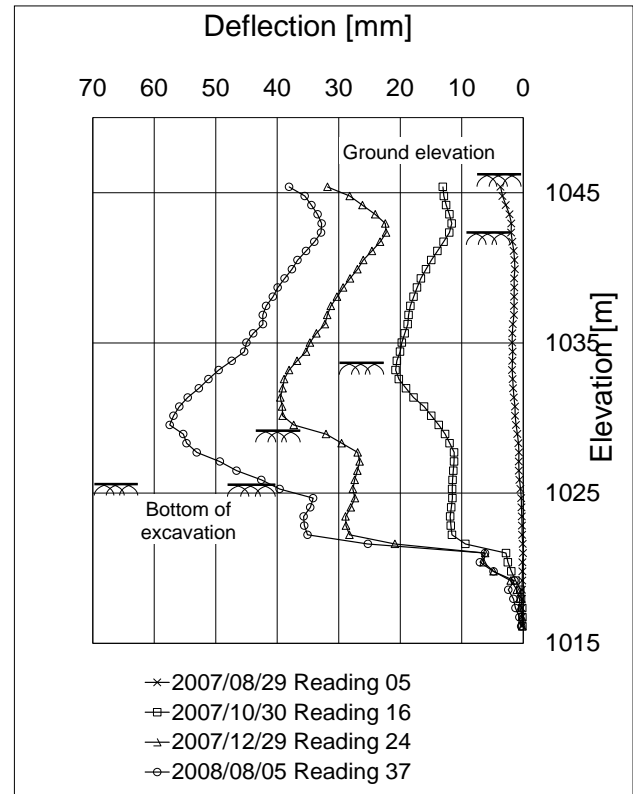
As excavation proceeded and results of monitoring became available, it became evident that potential threat of excessive deformation exists. Figure 17 shows that even though the excavation was only 12 m deep and was 6 m into rock and 14 m above the shear band, the displacement at the shear band had already been triggered resulting in a displacement of 10 mm. It was therefore necessary to define the uncertainties involved in the design problem and address these issues so that construction may proceed with a better understanding of the rock behaviour for construction control.

Figure 17. Inclinator 4 Readings

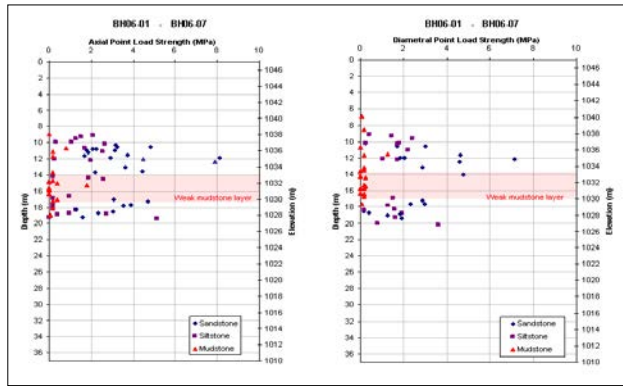
Figure 18. Point load strength profile

A detailed review of geotechnical site investigation report was performed. A summary plot of all the point load test results from BH06-01 to BH06-07 in both the axial and diametral directions are shown in Figure 18. It can be seen from the results of diametral point load test that there is a clear demarcation of a weak zone of mudstone exist within the depths of 13.5 m to 17 m across the area of the excavation. The results of axial tests did not give a distinct trend. The difference in behaviour is due to the layered nature of the rock. Failure in the axial direction tends to involve more than one layer while failure in the diametral direction tends to be tensile fractures in the weak mudstone. It will be shown that this weak zone correlates well with results of inclinometer monitoring. It also played a major role in contributing to some significant movements to the surrounding structures.

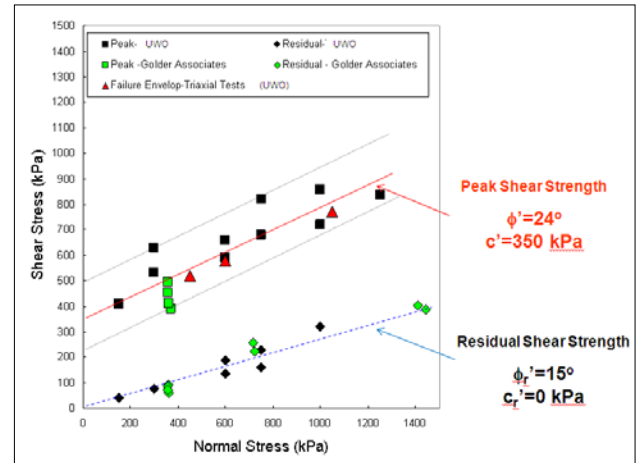
The results of shear box and triaxial tests are shown in Figure 19. To verify the reliability of test results, tests were performed at two laboratories. It can be seen that the results were quite consistent, yielding peak strength parameters of $c' = 0.35$ MPa and $\phi = 24^\circ$ and residual parameters $c_r' = 0$ MPa and $\phi_r' = 15^\circ$. Further details of test results and deformation parameters obtained therefrom may be found in Lo et al (2009). The engineering parameters employed in numerical analysis for each rock unit are summarized in Figure 20.

Figure 19. Multistage direct shear test results

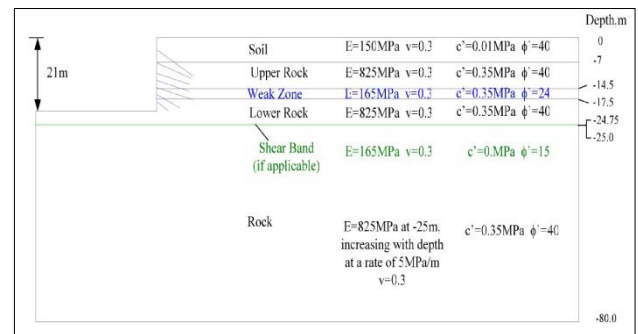
Figure 20. Engineering Parameters

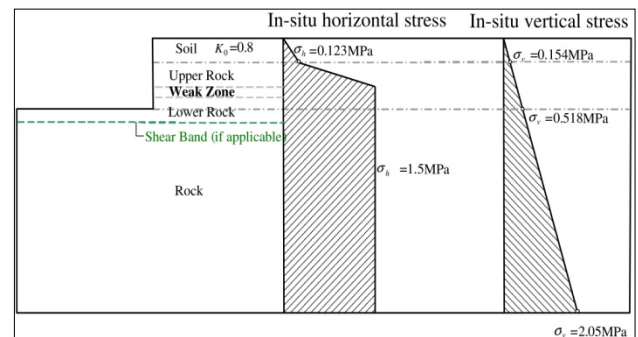
It appears that no in situ rock stress measurements have been carried out in the near surface rock formations in the Calgary area. Therefore, the magnitudes and directions of the in situ horizontal stresses which provide the driving force in rock deformation are not known. Based on experience of stress measurements in weak rock formation elsewhere, it was assumed that the magnitude of the horizontal stress may lie between 1 to 2 MPa. The distribution of assumed horizontal stress is shown in Figure 21, together with the vertical stress distribution based on overburden weight.

Figure 21. Assumed vertical and lateral *in-situ* stresses

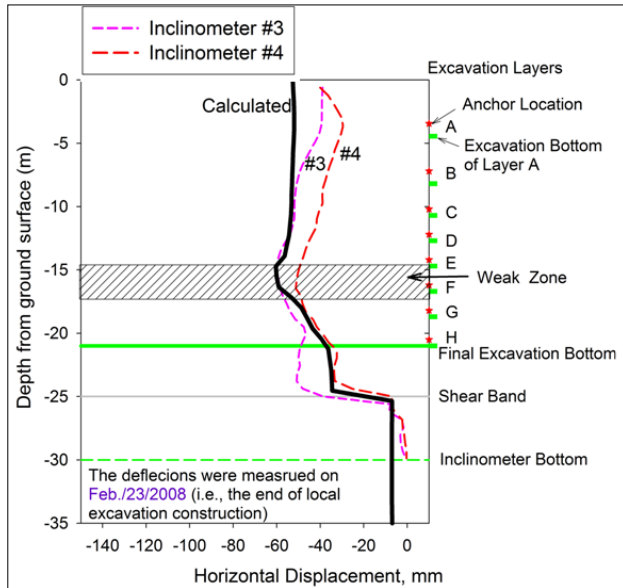
Figure 22. Calculated and measured deflections- North wall

The results of analysis at the north wall are compared with the results of monitoring from inclinometers No. 3 and No. 4 as shown in Figure 22.

The measured displacements from the two inclinometers are quite comparable and exhibit the same characteristics in the distribution of movements with depth. The calculated displacements show the same features. In particular, the following characteristics of movements may be observed.

- (i) The shear band induced an abrupt displacement of about 30 mm at a depth of 4 m below the bottom of the excavation.
- (ii) The weak zone between 14.5 m to 17.5 m depth caused a bulging effect at its corresponding elevations consistent with the results of diametral point load tests shown in Figure 18.
- (iii) The magnitude and depth of maximum lateral movement (60 mm) from monitoring and computations are consistent. The pattern of deformation behind the excavation is shown in Figure 23.

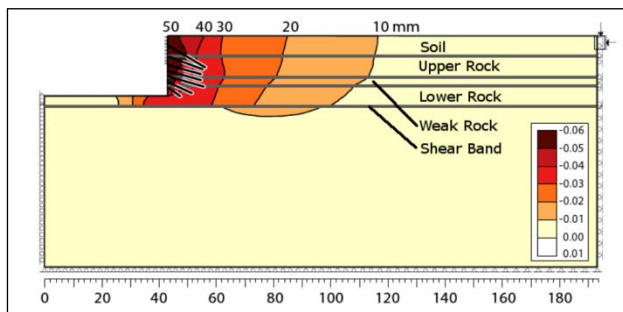
Figure 23. Computed horizontal displacements- North wall

It is significant to note that the displacement contours show a clear discontinuity at the shear band, indicating interface slip. This interface slip resulted in substantial lateral displacements far away from the excavation face as shown in the figure. Thus, at a distance approximately 4 times the depth of the excavation, the horizontal displacement is still as much as 10 mm.

The maximum calculated settlement is 13.3 mm at a distance of about 10 m from the north wall. The maximum base heave is 28 mm at a distance of about 12 m from the excavation face. While no precise measurements were made with regard to these quantities, general observations at the site are quantitatively consistent with the estimates.

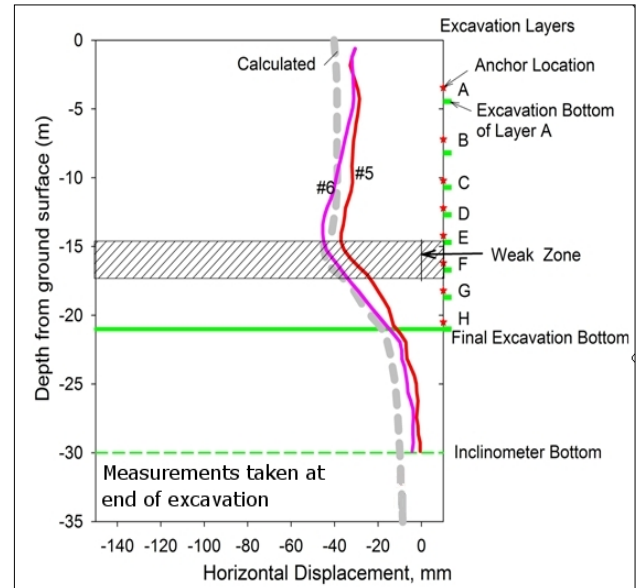
Figure 24. Calculated and measured deflections – East wall

The calculated and measured deflections at the East Wall at locations of inclinometer 5 and 6 are shown in Figure 24. At these locations the shear band did not exist but the effect of the weak zone was apparent. No abrupt discontinuity of the displacement distribution with depth occurred. As can be seen in Figure 24, the results of numerical analysis represent the measured deflections of

two inclinometers quite satisfactorily both in magnitude and distribution.

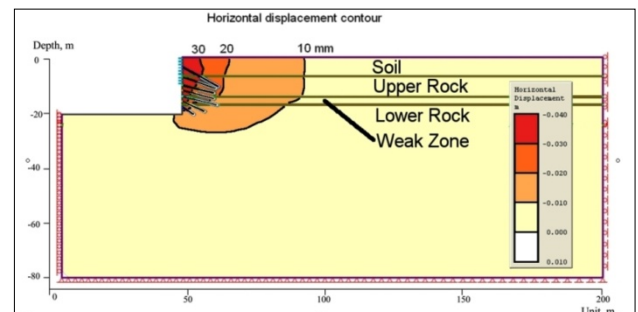
Figure 25. Computed horizontal displacement – East wall

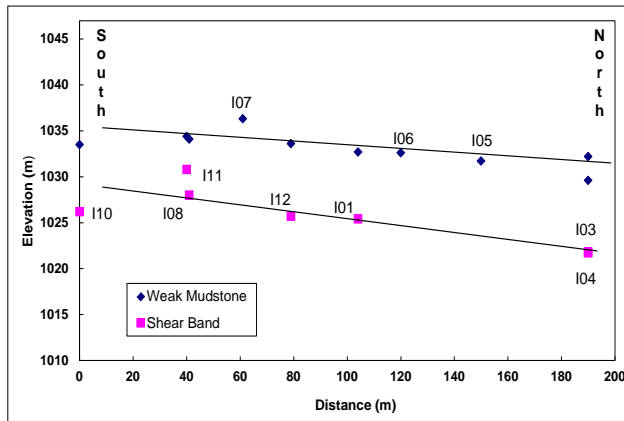
From results of inclinometer monitoring, it is possible to identify the occurrence and location of the weak zone and shear band across the site. The results are shown in Figure 26. It is noted that the weak zone was present at all locations monitored by the inclinometers.

Figure 26. Inclination of the weak zone and shear band across the site

The shear band, however, was not exhibited at locations of I05, I06 and I09. It is also interesting to note that both the shear band and weak zone have apparent movement towards the Bow River in the north.

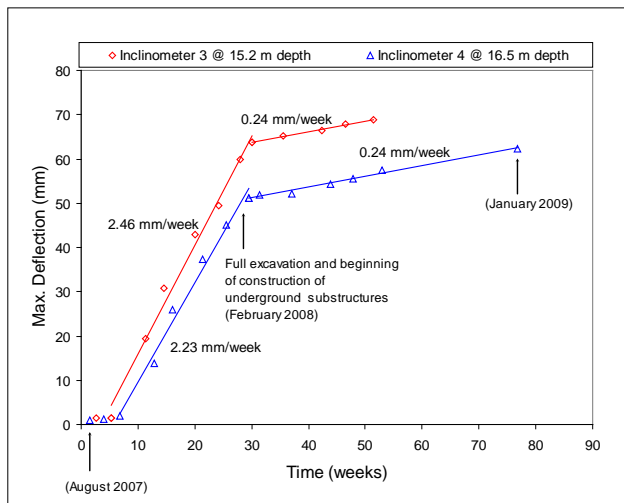
Figure 27. Maximum deflection vs. time inclinometers at the north wall of the Bow excavation
