## STABILITY ANALYSIS ACCOUNTING FOR MACROSCOPIC AND MICROSCOPIC STRUCTURES IN CLAYS

K.Y. Lo, Professor Emeritus and Director, Geotechnical Research Centre, Faculty of Engineering, The University of Western Ontario, London, Ontario, Canada, N6A 5B9

S.D. Hinchberger, Assistant Professor and Research Director, Geotechnical Research Centre, Faculty of Engineering, The University of Western Ontario, London, Ontario, Canada, N6A 5B9

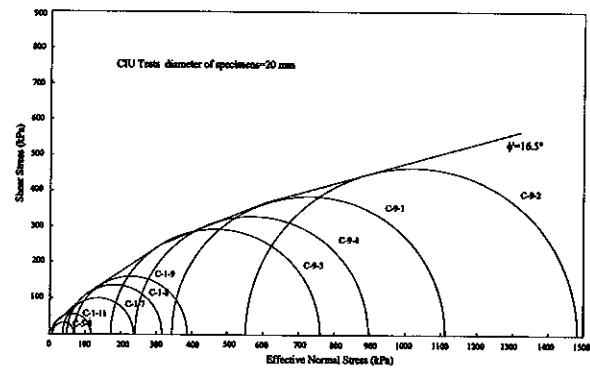
Figure 1. Effective strength envelope of Nanticoke Clay from 4.5 m depth

Figure 1 shows the Mohr-Coulomb envelope determined from intact specimens trimmed from block samples of insensitive stiff fissured clay taken at the Nanticoke Generation Station, Ontario (Vallée 1969). It can be seen that the envelope is mildly nonlinear over a wide stress range with strength increasing with effective stresses. This behaviour is also exhibited in other materials such as intact rock and concrete.

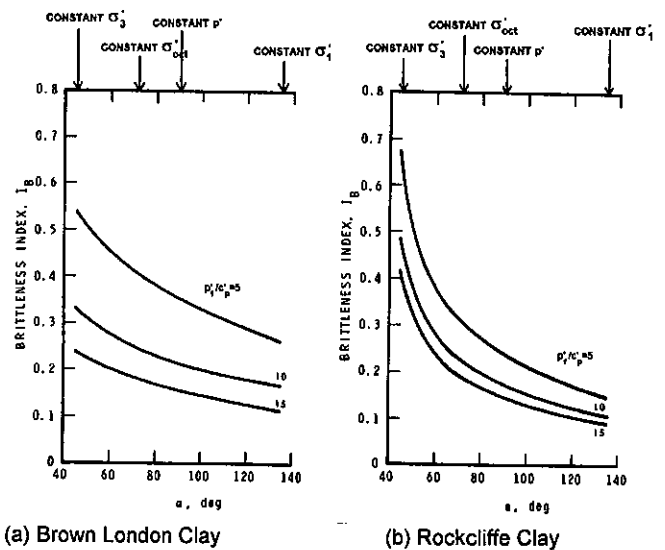
Figure 9. Effect of stress path on brittleness index of clays (after Law 1981)

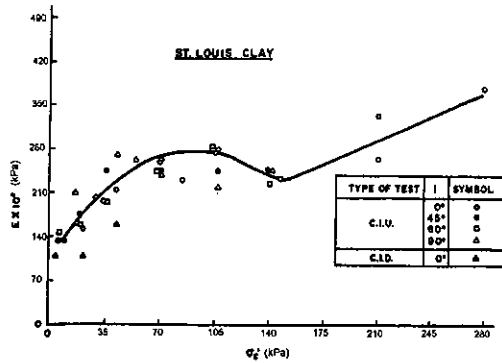
nature of bond rupture during shear can also be illustrated by Figure 14 in which the modulus of deformation of St. Louis Clay in CIU and CID tests are plotted against consolidation pressure. It can be seen that at half of the failure stress, the trend of modulus variation with consolidation pressure reflects that of the curved strength envelope shown in Figure 3.

Figure 14. Variation of modulus of deformation with consolidation pressure for St. Louis Clay (after Lo and Morin 1972)

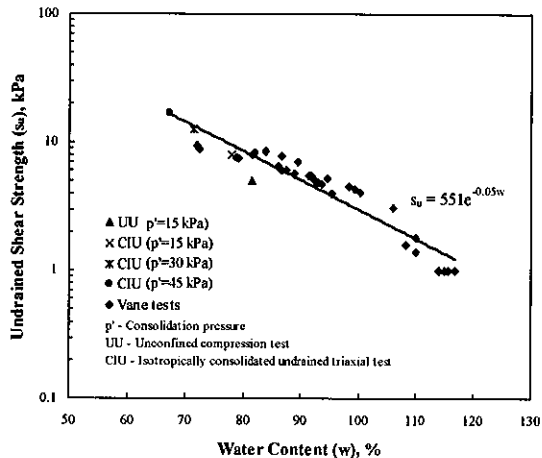
Figure 16. Undrained shear strength of untreated Yulchon soil versus water content

Analyses of the relationship between the undrained shear strength and water content of the normally-consolidated (7-15 days of consolidation) Yulchon Clay show that the undrained shear strength and water content of Yulchon soil yield an exponential relationship as shown in Figure 16. Results of isotropically-consolidated undrained triaxial (CIU) tests shown in Figure 17 indicate the ratio  $s_u/p'_c$  of 0.3, where  $p'$  is the consolidation pressure. This value is similar to the *in situ* value of  $s_u/p' = 0.26$  at the Yulchon site in South Korea reported by Hyundai Engineering and Construction Co. Ltd. (HDEC) in 1996. As expected, the stress-strain curves in Figure 17 showed no post-peak decrease in strength.

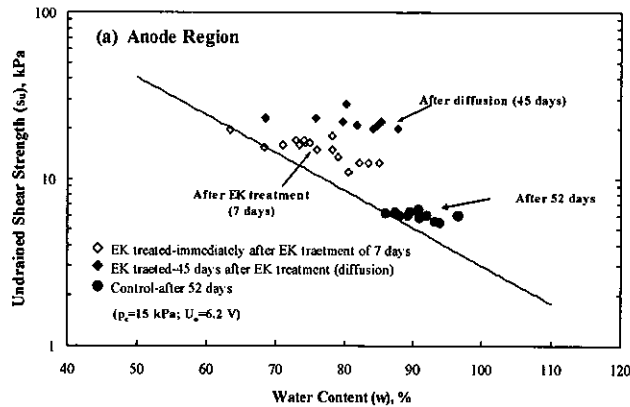
Figure 18. Undrained shear strength versus water content: (a) at anode and (b) at cathode

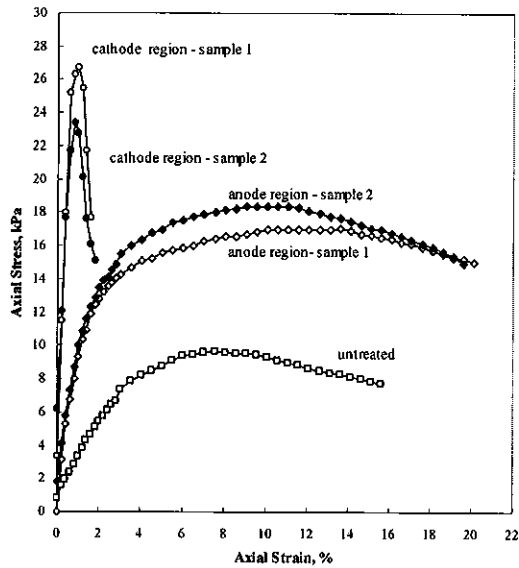
The stress-strain curves from unconfined compression tests on treated soil are presented in Figure 20. As can be seen, the results of compression tests are consistent with the results of vane tests discussed earlier, showing that the undrained shear strength increased due to EK treatment. In addition, brittleness developed in the soil as a result of electro-cementation. It is also noted that the brittleness is more prominent at the cathode than at the anode region, which is consistent with the strength development paths in Figure 19.

Figure 20. Results of unconfined compression tests

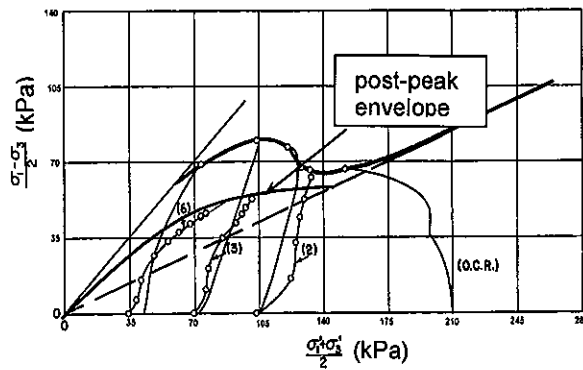
In an attempt to evaluate the bond strength under shear, three series of CIU tests were performed on St. Vallier Clay by isotropically consolidating specimens trimmed from block samples to pressures of 140, 210 and 280 kPa and then reducing the consolidation pressure to achieve OCRs up to eight (see Morin 1975). The results of one of the series are shown in Figure 23 in which the post-peak envelope from Figure 8 is also shown. It may be observed that for OCR exceeding three, the shear strengths lie close to the post-peak envelope but not on the extension of the unstructured envelope. Similar observations may be made on results from the St. Louis Clay. The results of these tests are an additional indication of the robustness of the post-peak envelope. Using this envelope as the baseline reference, the maximum bond strength under shear for St. Vallier Clay would be about 20 kPa and represents about 30% of the shear strength in the effective stress region considered. Similar results were also obtained for St. Louis Clay.

Figure 23. CIU-OC tests,  $i=0^\circ$ , Initial  $\sigma_c'=210$  kPa, St. Vallier Clay

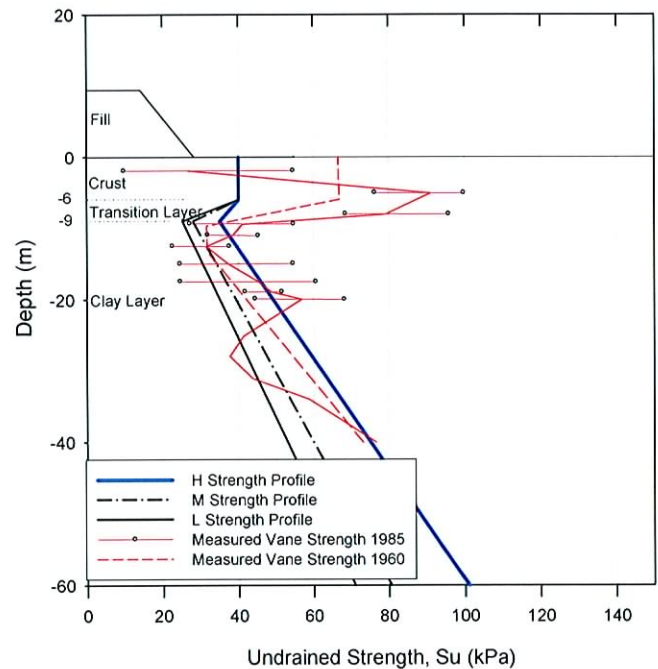
Figure 28. Distribution of vane strength with depth (adopted from Crawford et al. 1995)

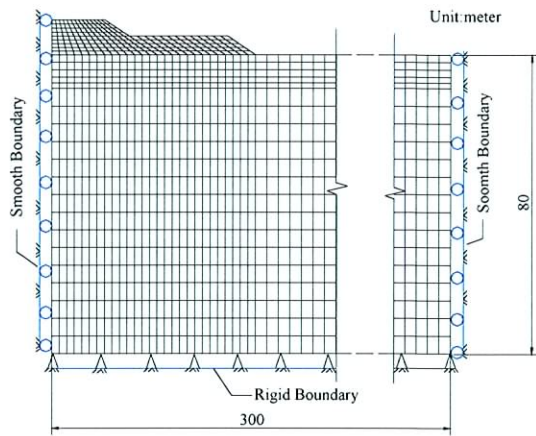
Figure 30. FEM mesh and boundary conditions

The construction of the embankment was simulated by activating the elements of fill material layer by layer, nine layers for the first failure and eleven layers for the second layer as shown in Figure 29. The mesh used is shown in Figure 30.

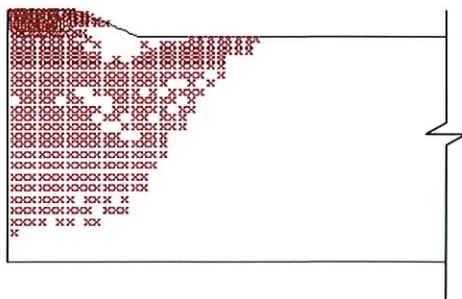
(a) Plastic Zone (H=8.3 m)

(b) Velocity Field (H=8.3 m)

(c) Plastic Zone (H=9.4 m)

(d) Velocity Field (H=9.4 m)

Figure 31. Plastic Zones and Velocity Fields at embankment heights of H=8.3 m and H=9.4 m

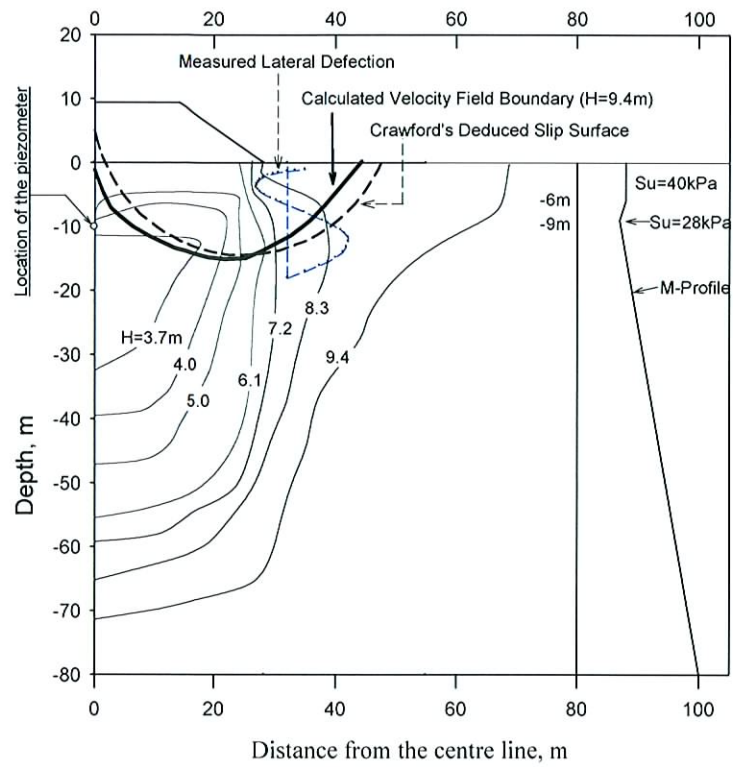
Figure 32. Development of plastic zone in the foundation at increasing embankment height

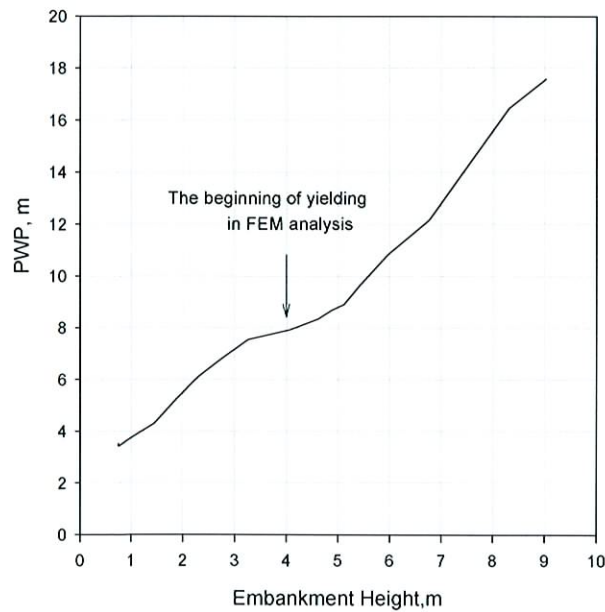
Figure 33. Measured pore water pressure on -10m depth at centre line of station 27+80

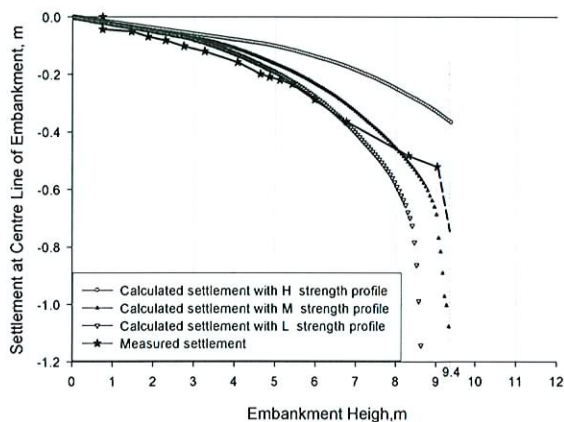
Figure 35. Measured and calculated settlements of the embankment centre station 27+80 (the first failure)

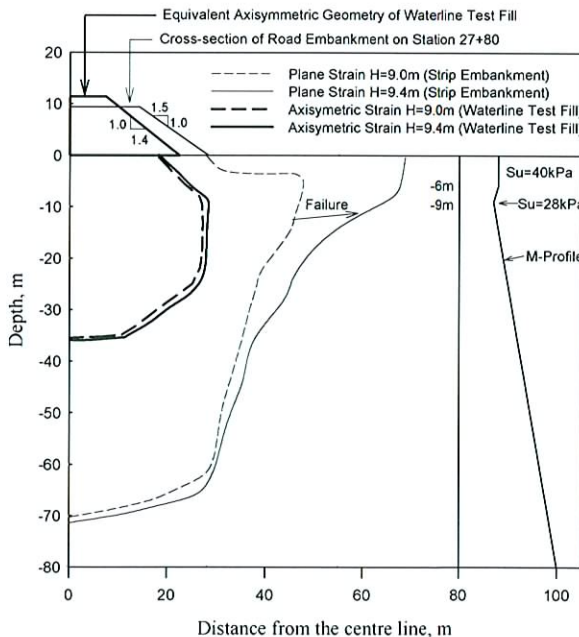
Figure 38. Development of plastic zones under Waterline test fill and strip embankment at station 27+80

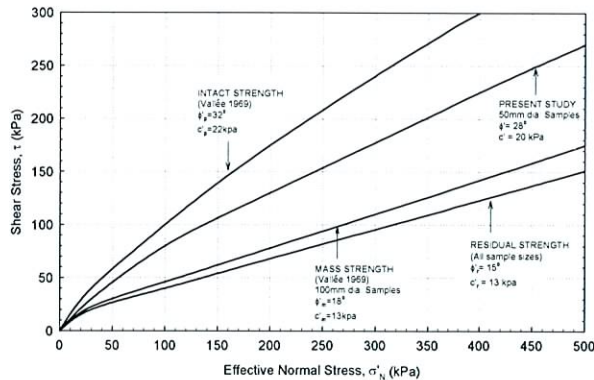
Figure 46. The effect of sample size on the effective strength envelope of Nanticoke clay (from Vallée 1969, Lo et al. 1969, and Liang 2006).
