Slope Stabilization of a Section of the Welland Canal

Dennis E. Becker
Ph.D, P.Eng., FEIC, FCAE

Principal
Golder Associates

April 2012

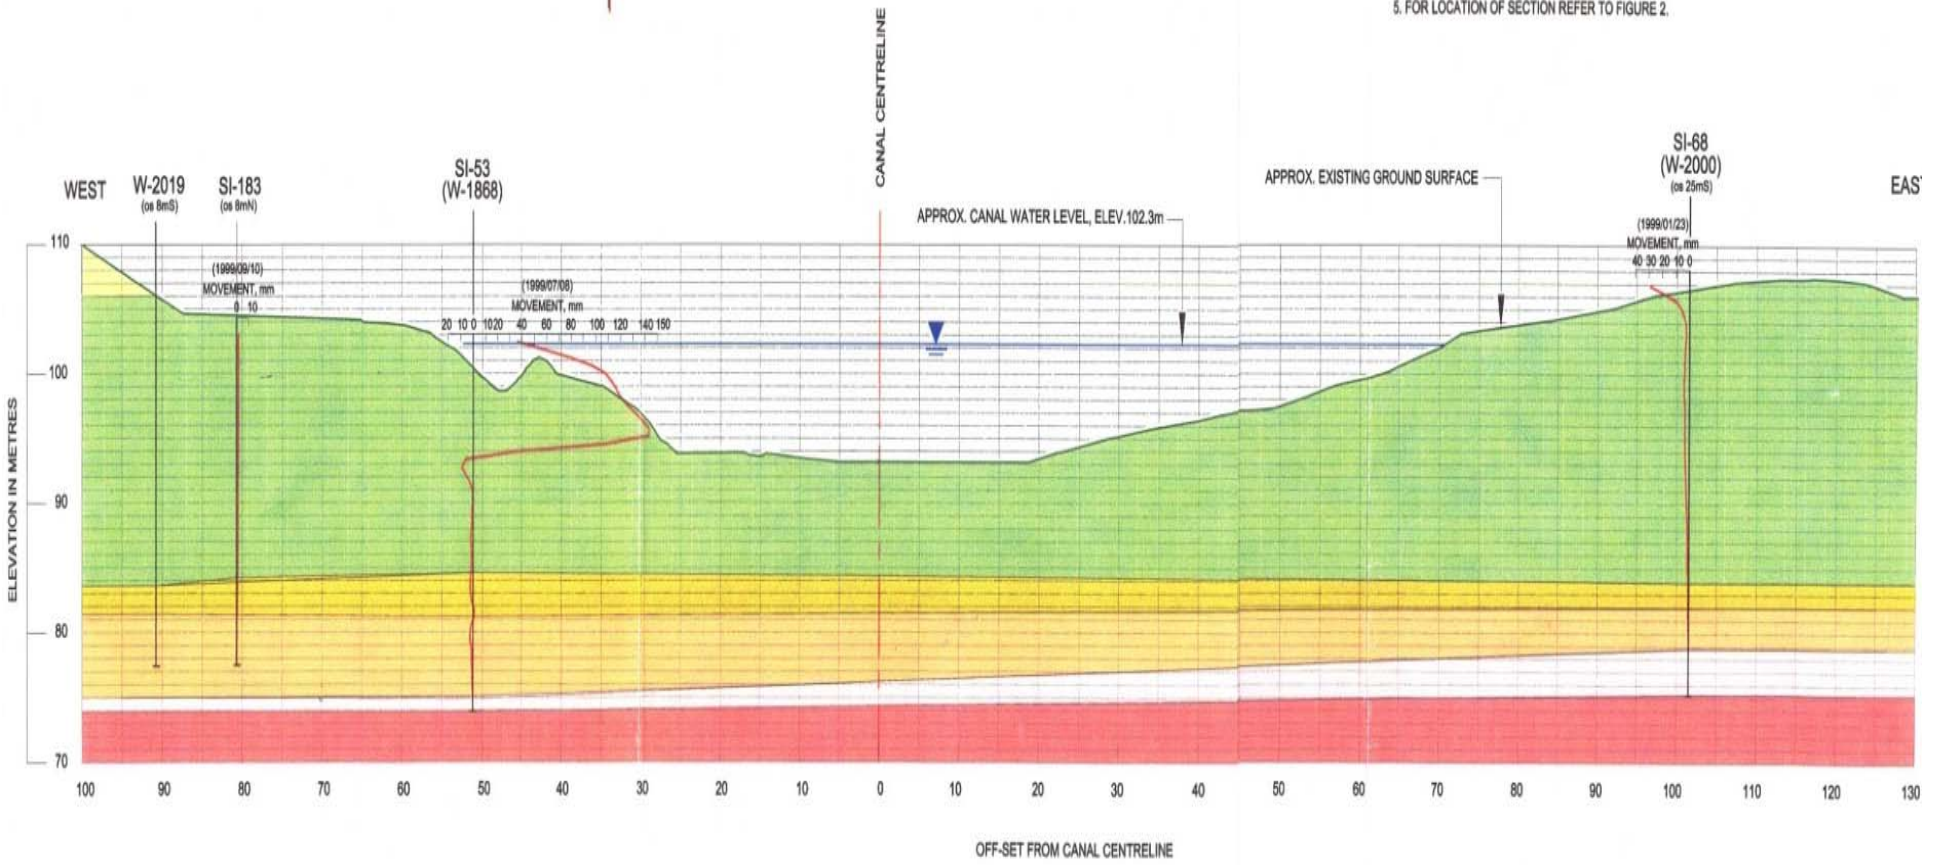
SECTION A-A

West Bank Movements

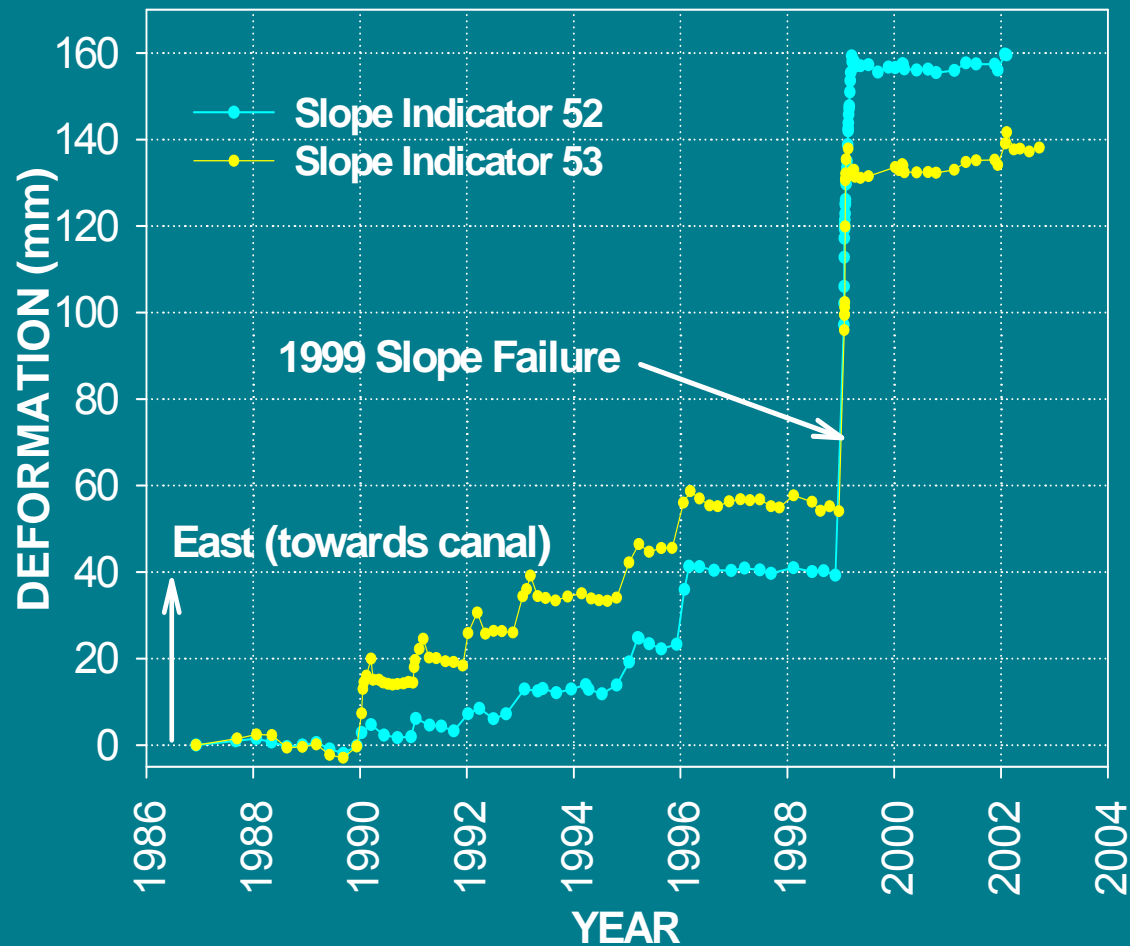
History of Slope Indicators 52 and 53
6 m depth

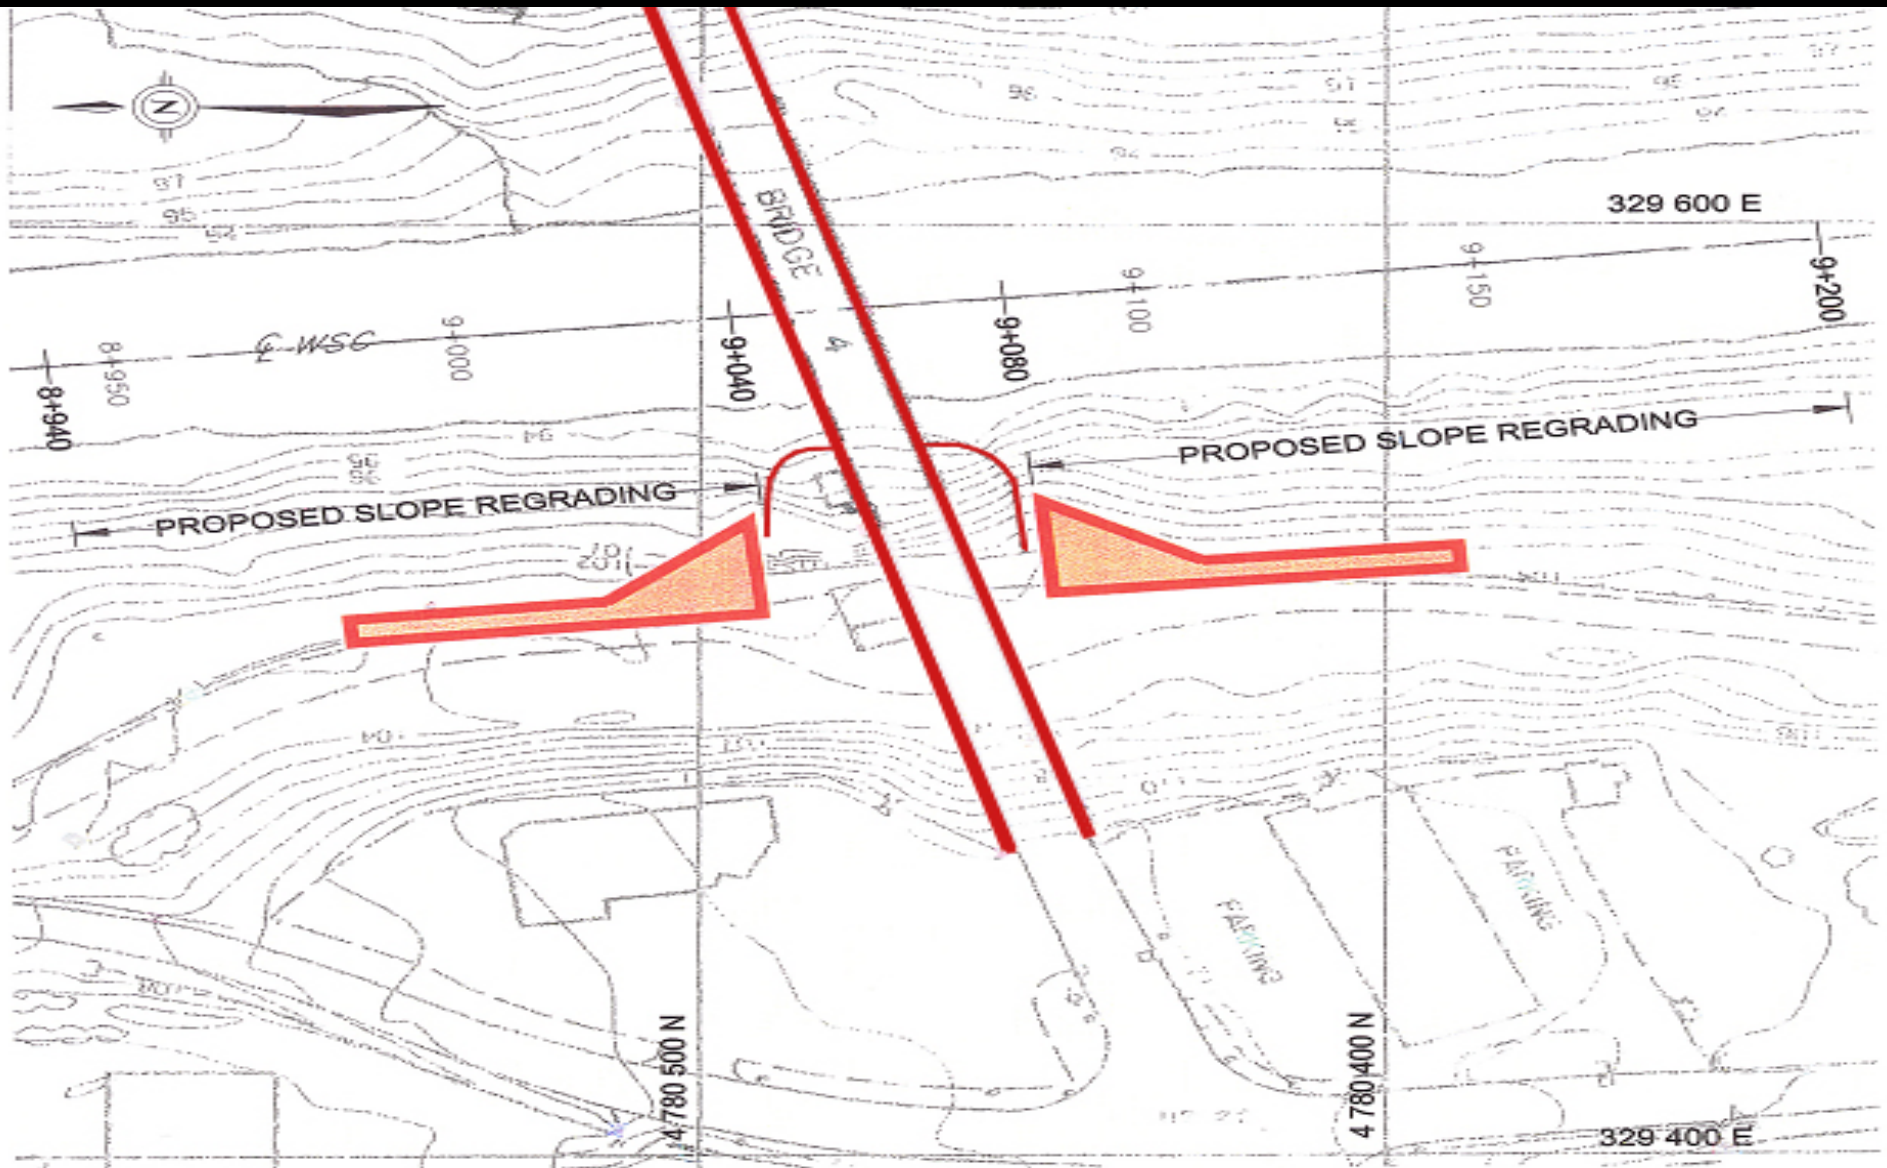
Conceptual Plan – Scheme 1 Pile Reinforced Soil and Slope Regrading Reach 2 Feasibility Study, Welland Canal

- Minimize number of canal dewatering cycles
- Soil Reinforcement:
 - micro-piles on both sides adjacent to west main pier
 - 600 piles 20 m long
 - \$ 2.5 M
- Structural Wall:
 - anchored caisson wall on both sides adjacent to west main pier
 - 100 m total length: 30 m deep
 - \$2.7 M

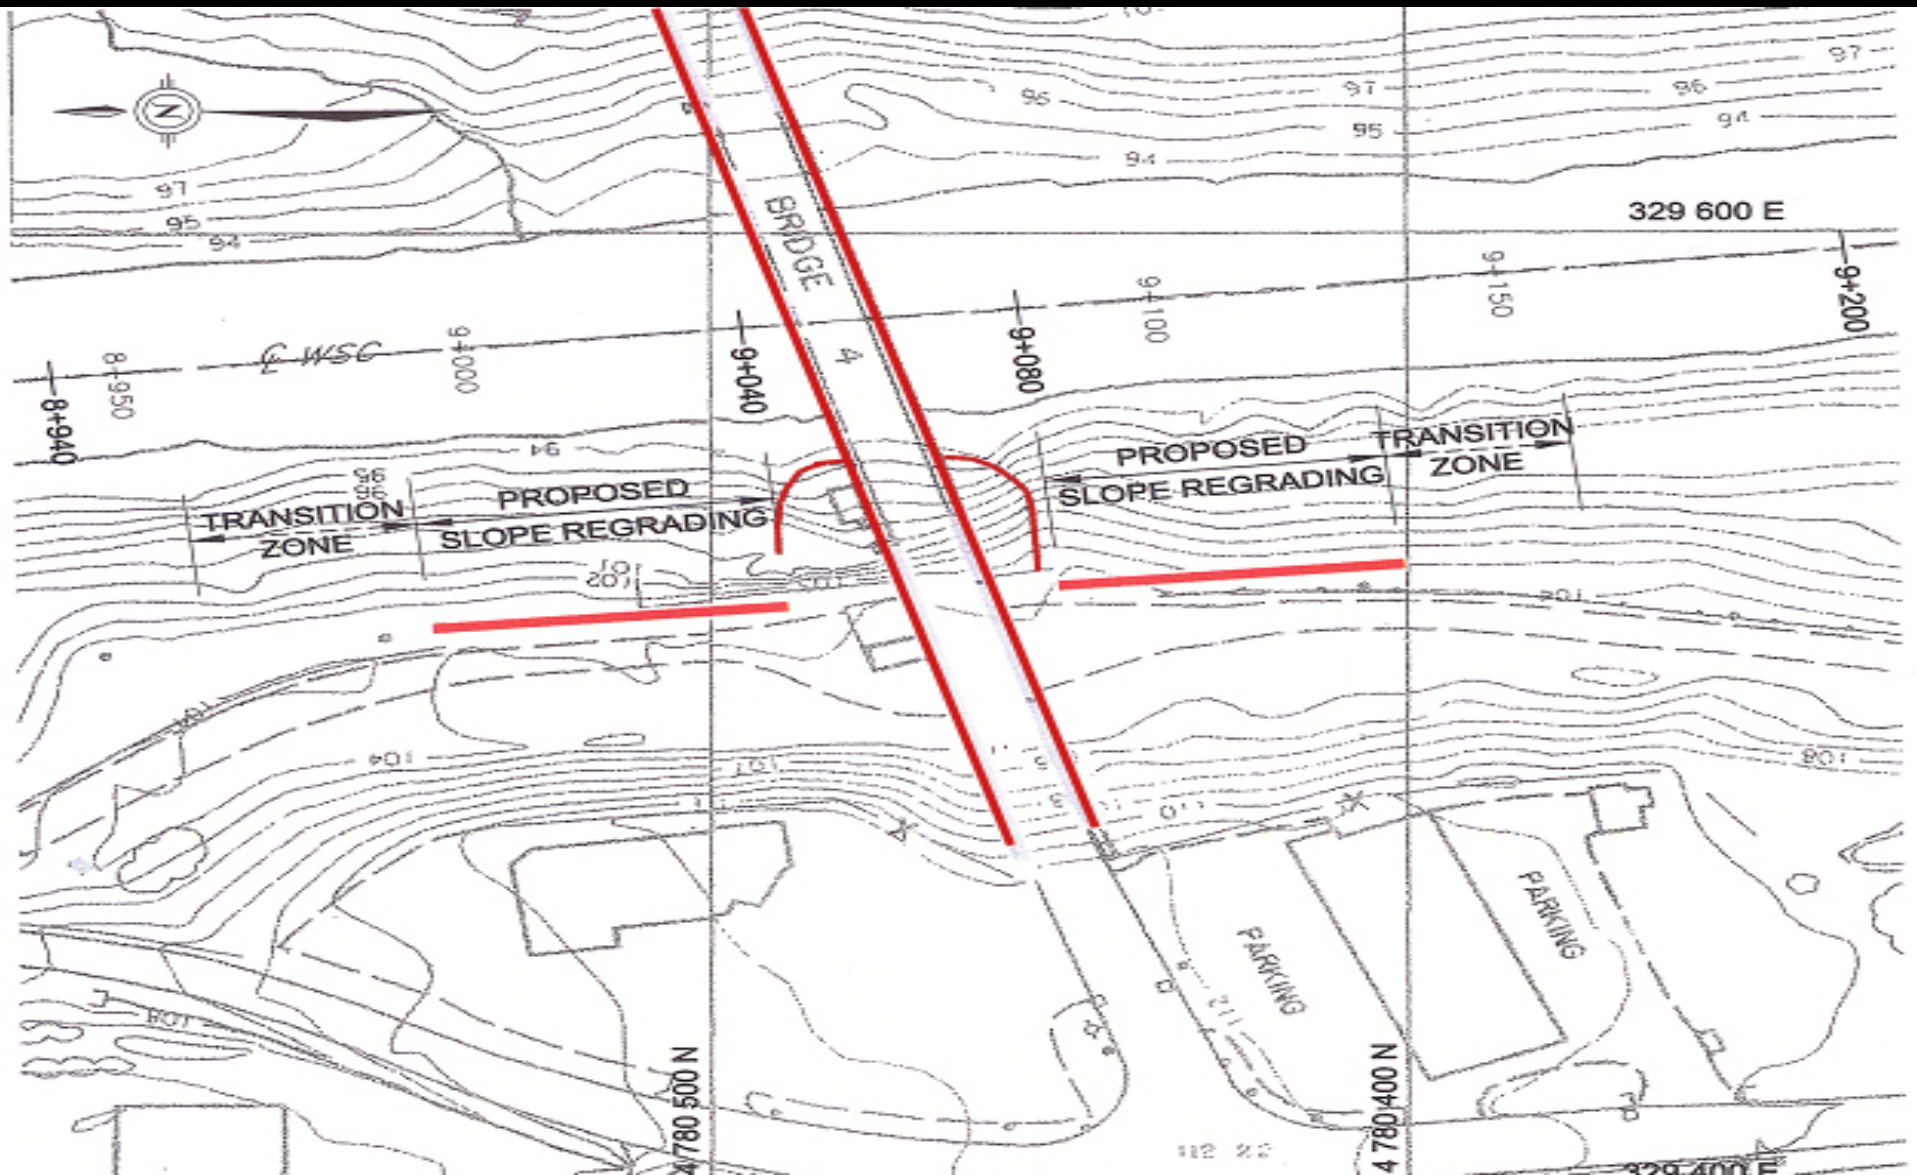
Conceptual Plan – Caisson Wall – Scheme 3 Reach 2 Feasibility Study, Welland Canal

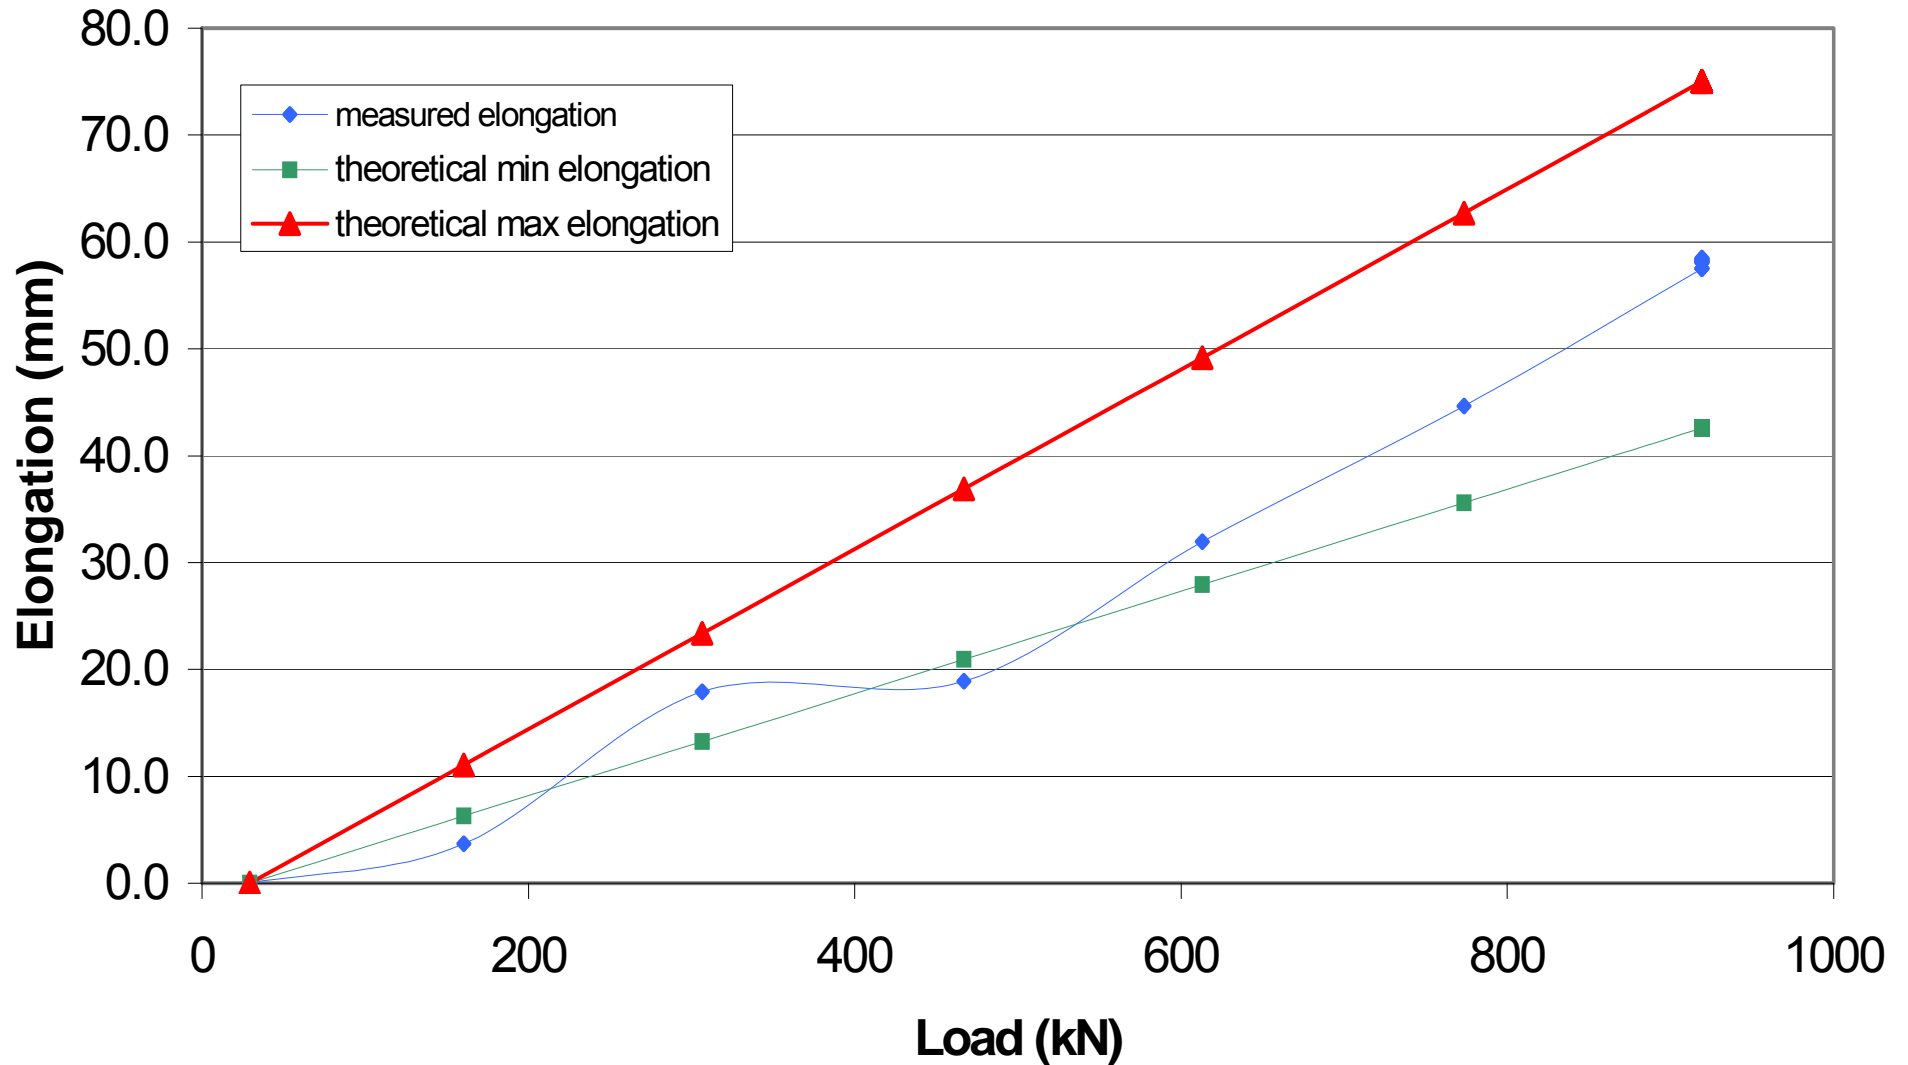
- All anchors satisfied performance specification:
 - elongation: > 60% of elastic elongation of FREEL
< 100% of elastic elongation of (FREEL + 0.5x BOND L)
 - creep not exceed 2 mm during final time log cycle

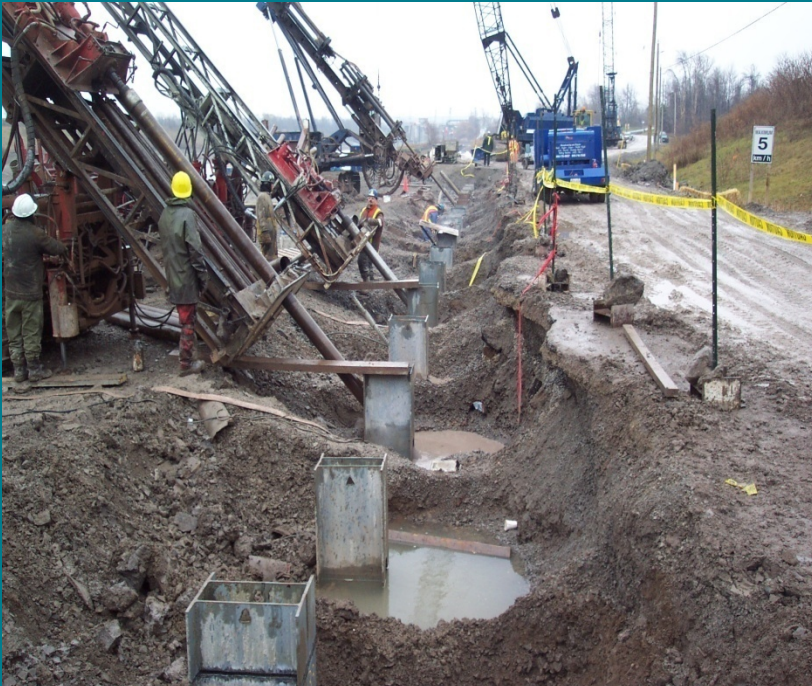
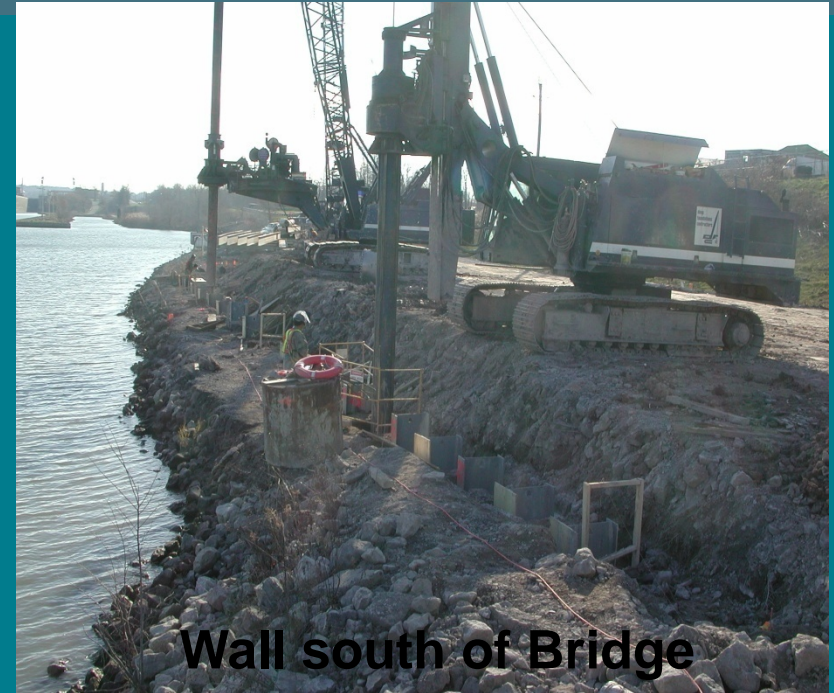
Anchorage Caissons south of Bridge

- Construction carried out along west bank
 - No disruption to Canal operations
 - Equipment not placed on lower slope where shear strengths as low as 15 kPa exist
 - Toe berms along lower slope maintained
- Lower slope in front of wall regraded after wall in place to improve stability
